Oakwood Junior High / High School

Oakwood City Schools
Oakwood, Ohio

Technical Building Assessment Report

September 4, 2018

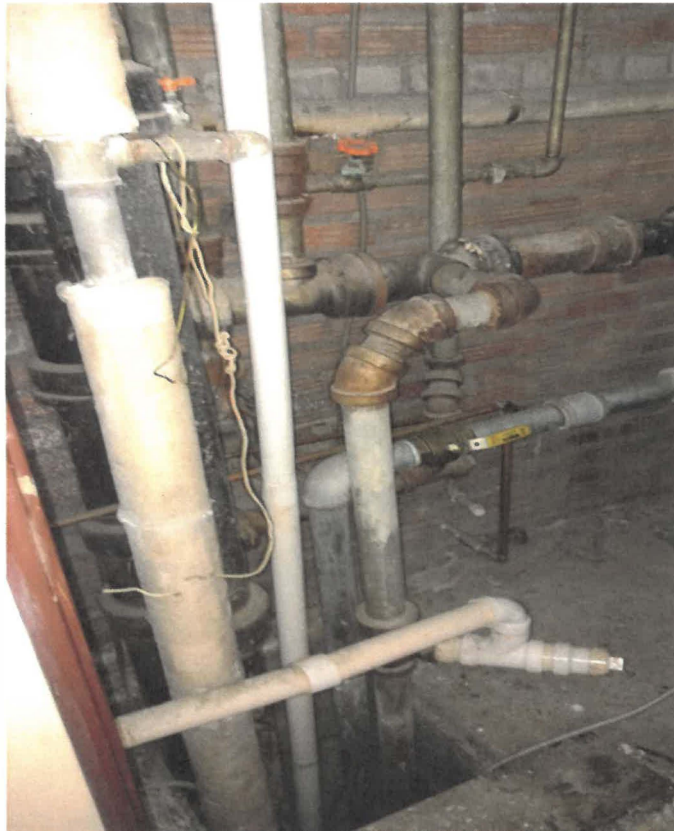
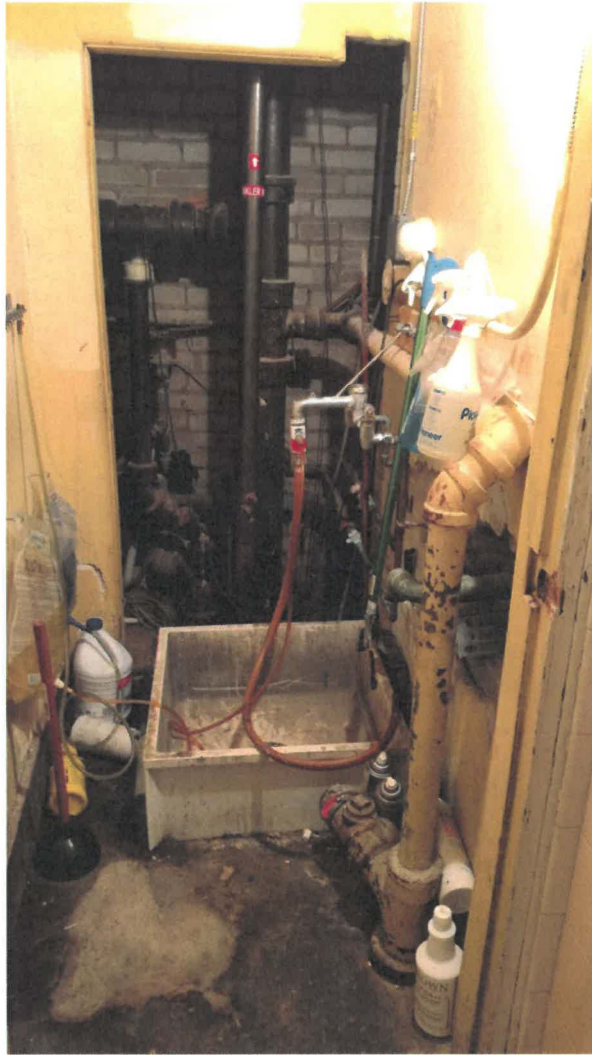
- The original sanitary piping is in poor condition and has collapsed in many locations. Replace all original sanitary piping.
- The existing sanitary piping in the 2005 Addition was found to be satisfactory.

| Sprinkler - 2005 Addition | 14,156 | sf | Full wet sprinkler throughout | 3 | \$ - | - | | |
| | | | | | | - | | |
| Sanitary Piping - High School/Junior High | 164,082 | sf | Original sanitary piping is in poor condition and has collapsed in many locations. Replace all original sanitary piping. | 1 | \$ 2.42 | 158,831 | X | |

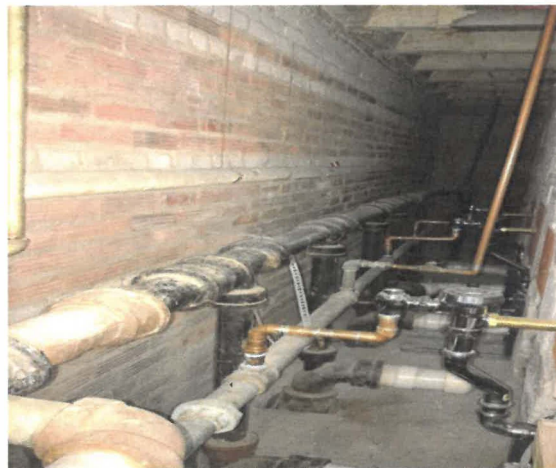
- The original domestic water piping is primarily galvanized that is in poor condition. Replace with new copper piping throughout. The 2005 Addition piping is in satisfactory condition.

| Sprinkler - 2005 Addition | 14,156 | sf | Full wet sprinkler throughout | 3 | \$ - | - | | |
| | | | | | | - | | |
| Domestic Water Piping - High School/Junior High | 164,082 | sf | Original domestic water piping is primarily galvanized and should be replaced with copper piping. | 2 | \$ 2.20 | 144,392 | X | |

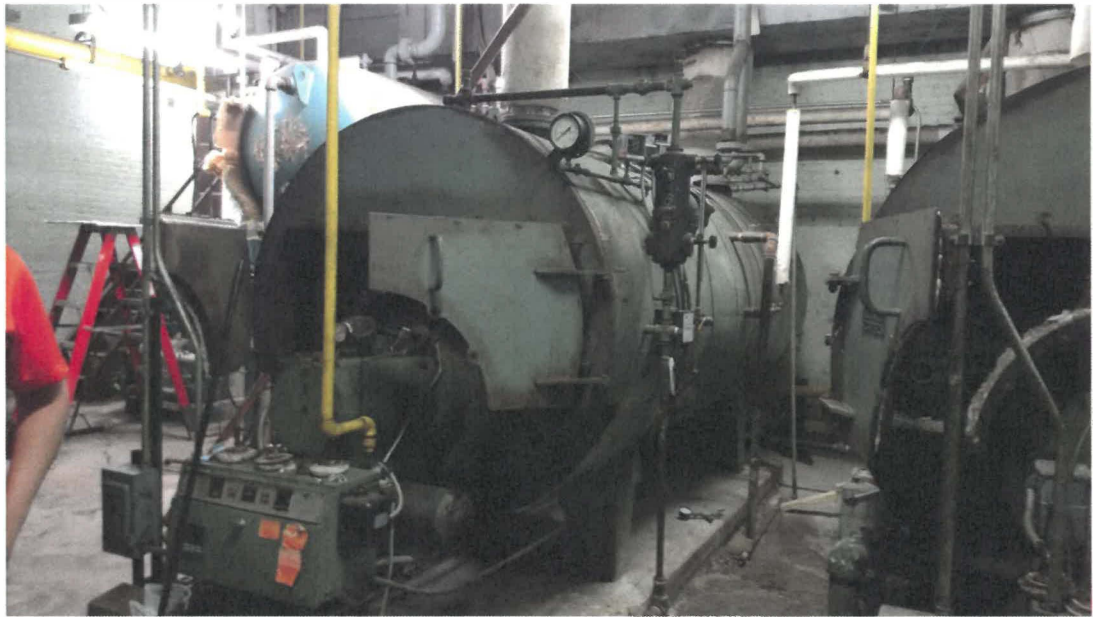
- The existing fire-tube steam boilers (10,000 MBH) are past any useful life and are in need of replacement. We are recommending consideration for a high-efficiency, condensing boiler plant.

| Sprinkler - 2005 Addition | 14,156 | sf | Full wet sprinkler throughout | 3 | \$ - | - | | |
| | | | | | | - | | |
| Boiler Plant - High School/Junior High | 10,000 | mbh | Fire-tube steam boilers, should be replaced with new condensing heating water boilers. | 2 | \$ 27.10 | 271,000 | X | |

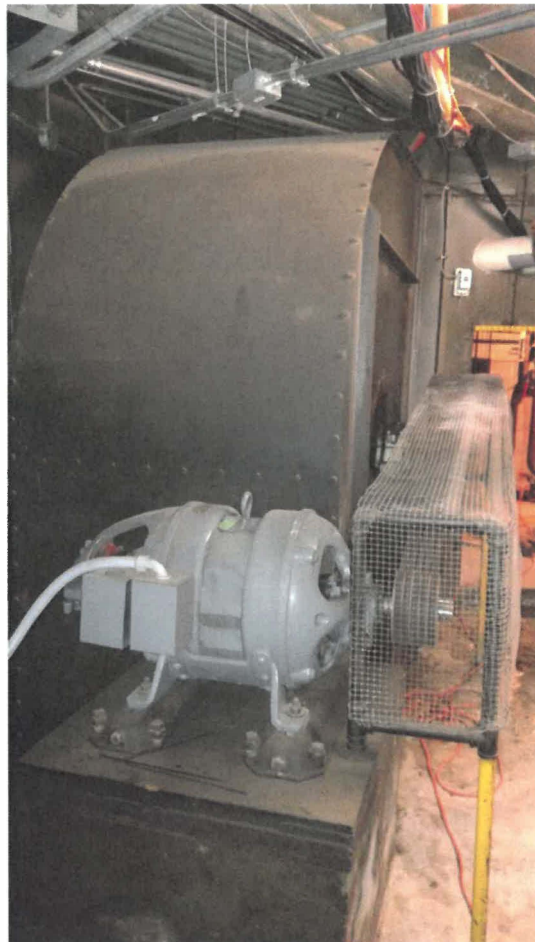
- The existing central heating and ventilating unit for the high school has exceeded its life expectancy and should be replaced with a new dedicated outdoor air handling unit and 25 new 4-pipe fan coil units. FCUs will be located in the classrooms.

| Original Air System - High School | 52,800 | cfm | Existing central heating and ventilating unit has exceeded its life expectancy and should be replaced with new dedicated outdoor air handling unit and (25) 4-pipe fan coil units. | 1 | \$ 21.70 | 1,145,760 | X | |

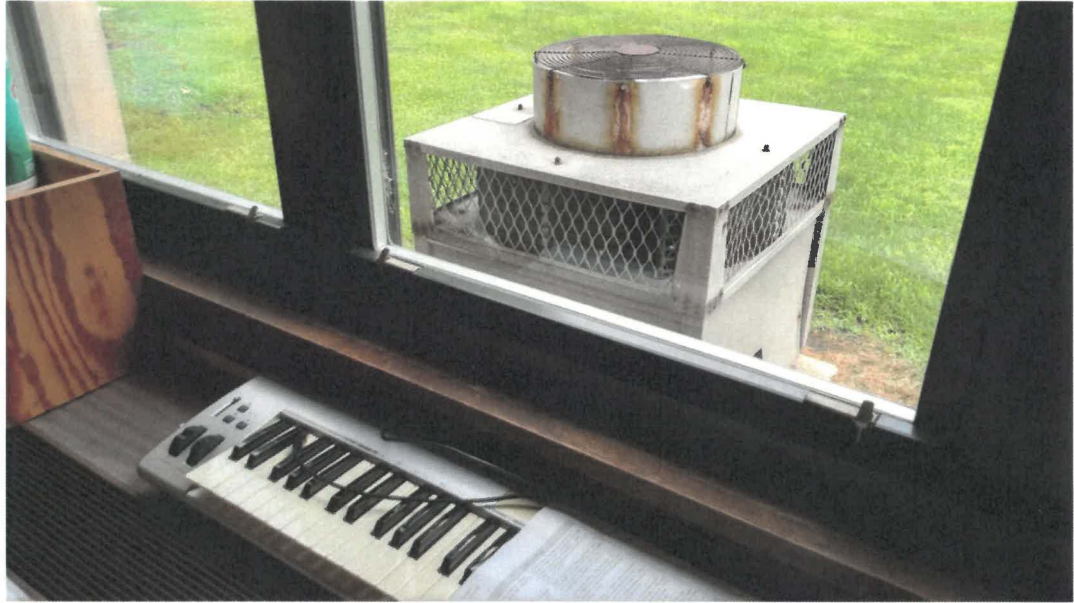
- The existing central heating and ventilating unit for the junior high school has exceeded its life expectancy and should be replaced with a new dedicated outdoor air handling unit and 16 new 4-pipe fan coil units. FCUs will be located in the classrooms.
- The existing auditorium air handling unit was replaced in 2005 and is in generally good condition. To add cooling to the system, a chilled water coil can be added to the unit with changes in controls and the installation of a new central chilled water plant.
- The existing direct-expansion (DX) classroom units shall be replaced with new, 4-pipe unit ventilators for heating and cooling those spaces.

| Original Air System - Junior High | 12,900 | cfm | Existing central heating and ventilating unit has exceeded its life expectancy and should be replaced with new dedicated outdoor air handling unit and (16) 4-pipe fan coil units. | 1 | \$ 21.70 | 279,930 | X | |

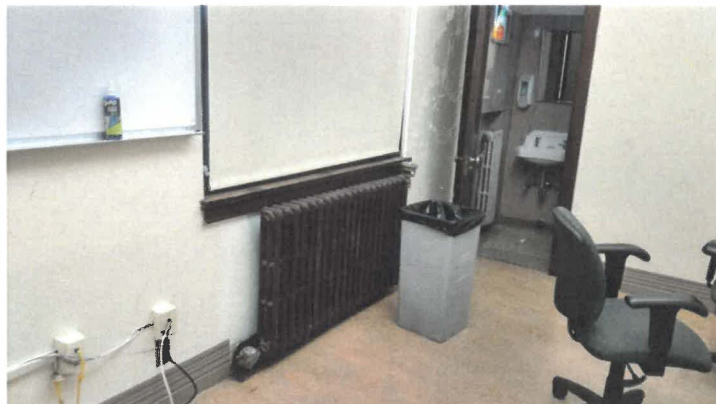
- The existing DX cooling and steam heating air handling unit that serves the high school administration area has exceeded its useful life and should be replaced with a new chilled water and heating water variable air volume air handling unit with a downstream VAV ductwork system. The existing junior high administration area system is in good condition, although the existing steam radiators should be replaced with new, heating hot water fin radiation.

| High School Administration Unit | 1500 | cfm | Existing DX cooling and steam heating air handling unit service the HS administration area has exceeded its life expectancy and should be replaced with a new chilled water and heating water variable air volume air handling unit and 7 VAV reheat terminals. | 1 | \$ 12.35 | - | | X |

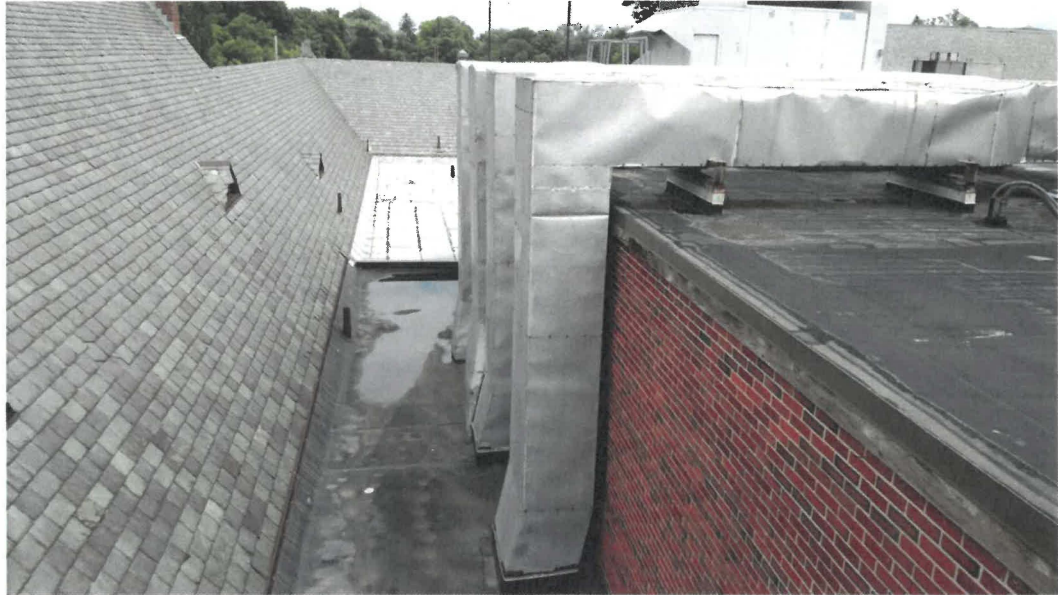
- The existing heating and ventilating air handling unit for the gymnasiums have exceeded their useful life and will be replaced and operated from the new central heating water system and central chilled water system.

| Junior High Gymnasium Unit | 10,000 | cfm | The existing heating and ventilating gymnasium air handling units have exceeded their life expectancy and should be replaced with a new chilled water cooling and heating water air handling unit. | 1 | \$ 9.50 | 95,000 | X | |

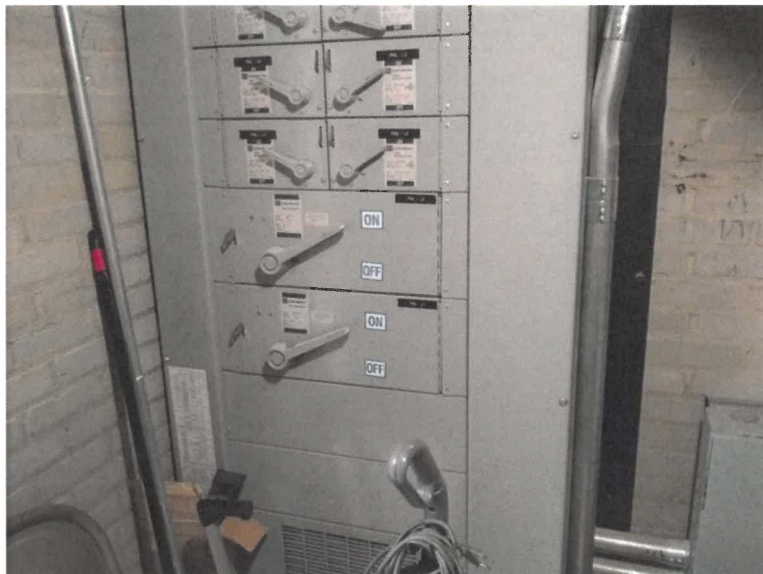
- New 1200A 480V electrical service is required to serve new HVAC (chiller) loads. The new service will consist of a 1200A distribution panelboard with approximately 10 circuit breakers.
- There are several existing distribution panels that are serving as switchgear that are in satisfactory condition and should remain. This includes (5) 800 amp and (5) 400 amp switches.

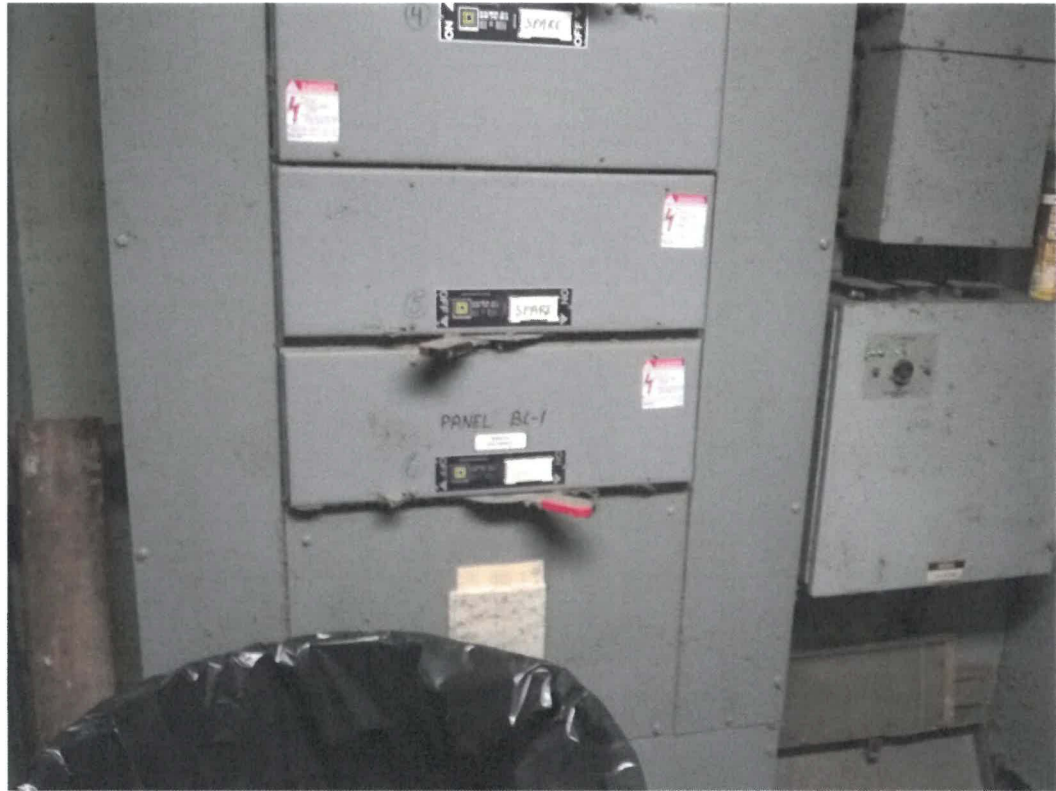
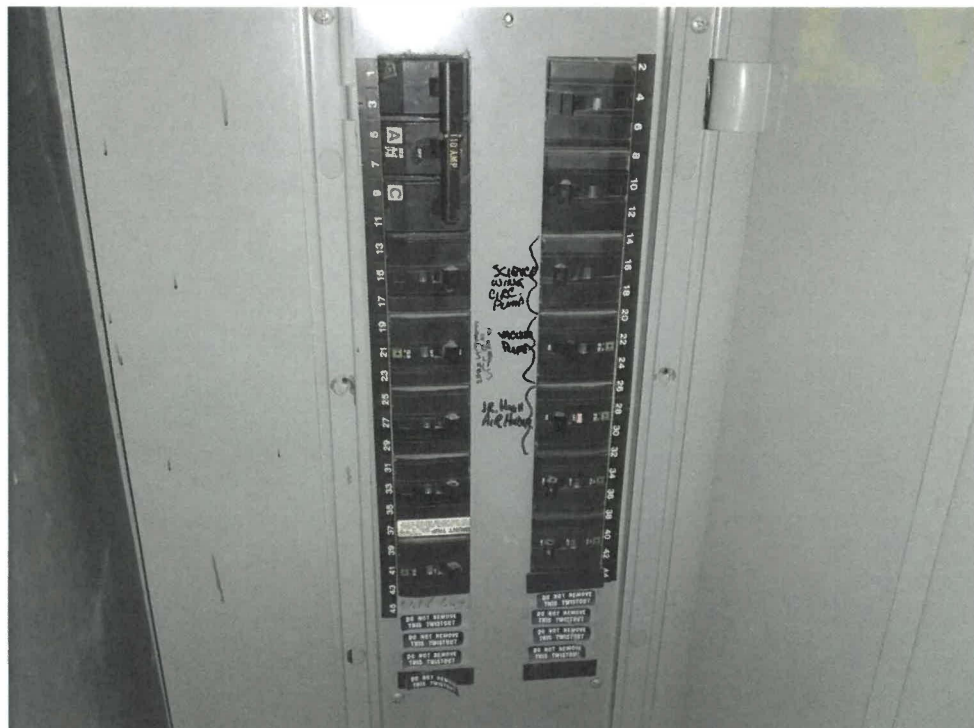
- There is an old 800 amp switchboard that is beyond its useful life and should be replaced as a part of the electrical service upgrade. A number of old/damaged panelboards in the building are also in need of replacement.

| Client: | | Oakwood City Schools | | | | 1. End of useful life | | <div> <div></div> <div></div> <div></div> <div></div> <div></div> </div> | |
|---|---|---|---|--|---|---|---|--|---|
| | | 1 | ea | Older 800A switchgear (Square D). Needs replaced. | 2 | 36,300.00 | 36,300 | X | |
| | Panelboards | 14 | ea | Old/Damaged Panelboards. Need Replaced. Assume 42 ckt. 225A. | 2 | 5,325.00 | 74,550 | X | |

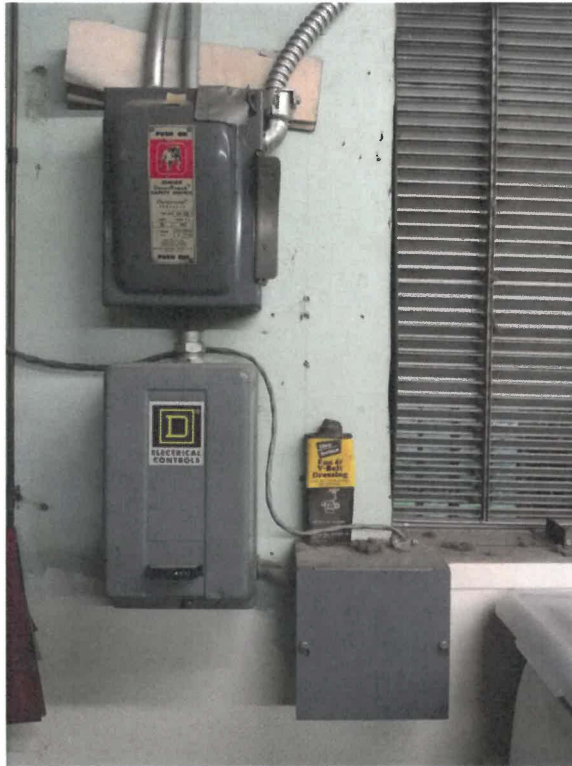
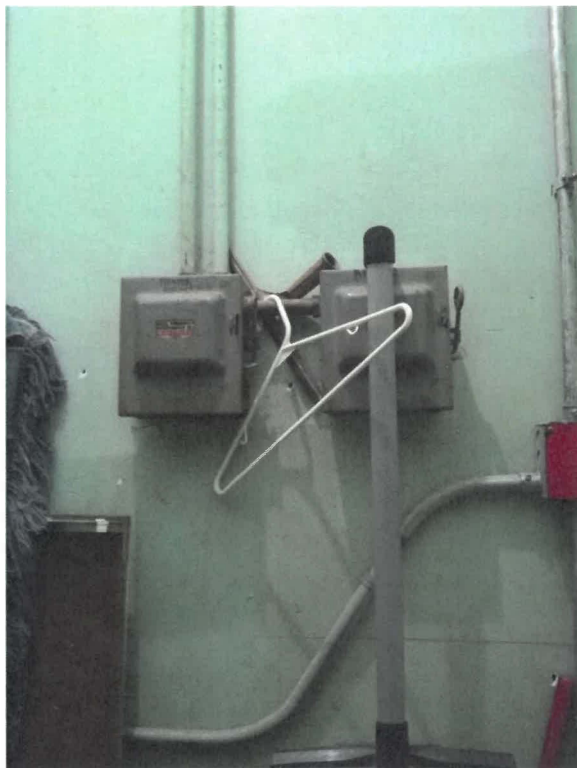
- There are up to 6 old and damaged disconnect switches that are in need of replacement. There are also up to 8 existing disconnect switches that are fairly new and in satisfactory condition that will remain in service.

| Client: | | Oakwood City Schools | | | | 1. End of useful life | | <div> <div></div> <div></div> <div></div> <div></div> <div></div> </div> | |
|---|---|---|---|--|---|---|---|--|---|
| | Disconnects | 6 | ea | Old/Damaged Disconnects. Need Replaced | 2 | 1,200.00 | 7,200 | X | |

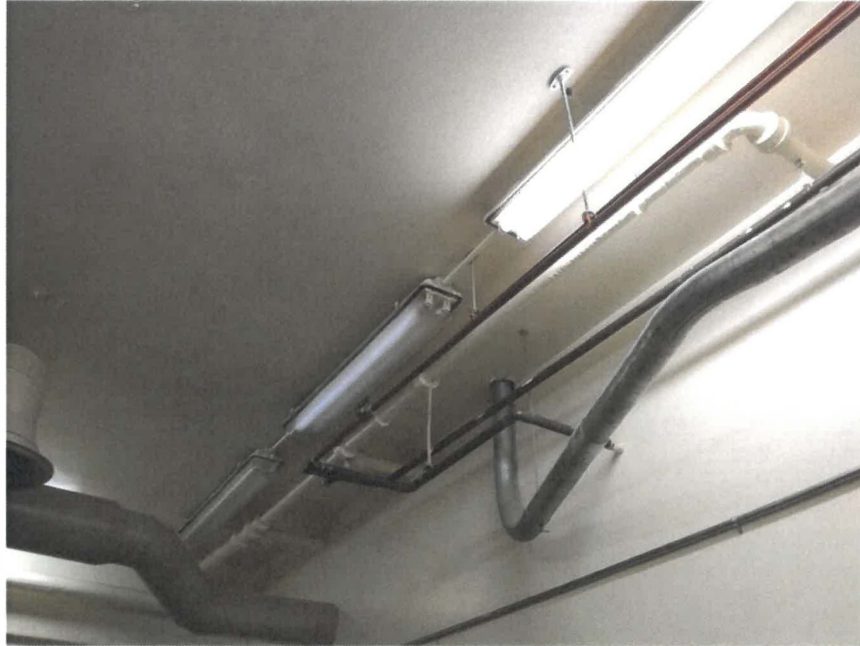
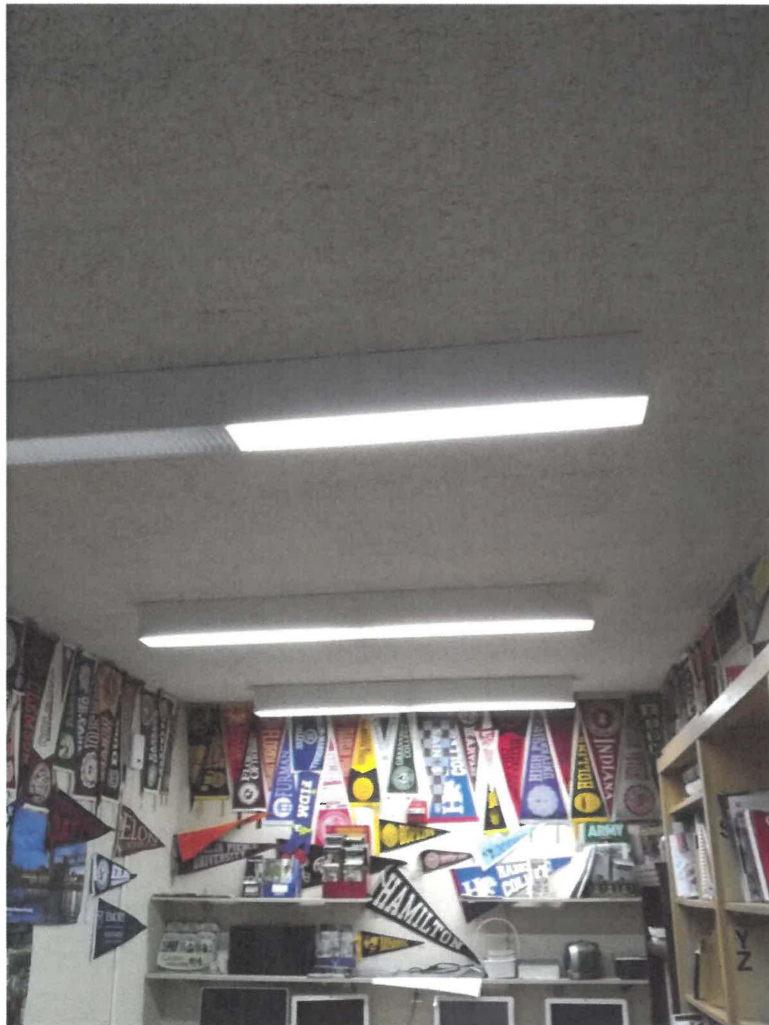
- As a part of a total building upgrade, we are recommending that lighting throughout the facilities be replaced with new LED fixtures and lamping. The payback for this effort will be no more than 2-3 years and will result in less maintenance and lamp replacement costs. The replacement would include the high-bay HID lights that are being used in the JH gymnasium and the old incandescent lighting in the HS gymnasium.

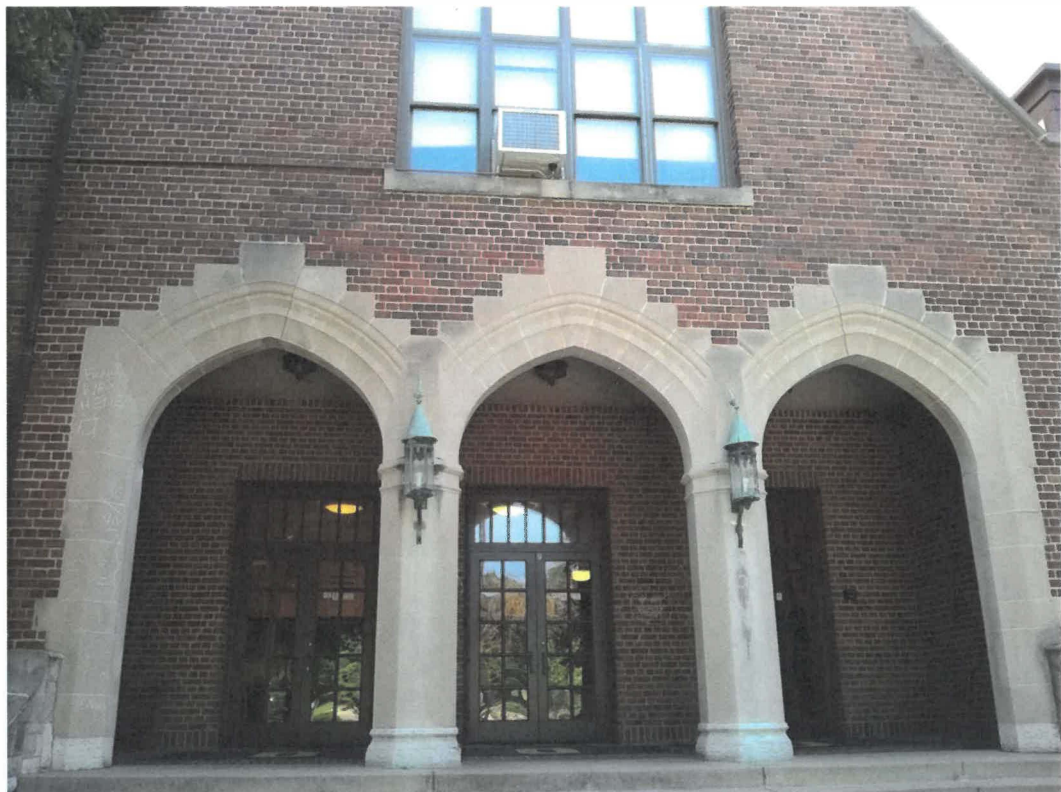
- We are recommending that the exterior lighting fixtures including pole lights and building lights be upgraded to LED lighting. The change will enhance lighting and control. Care will be taken when replacing architecturally critical exterior fixtures (wall sconces at the entrances) to either replace the lamping only with LED or match the look of the fixture being replaced. Exterior fixtures installed in 2005 will remain.

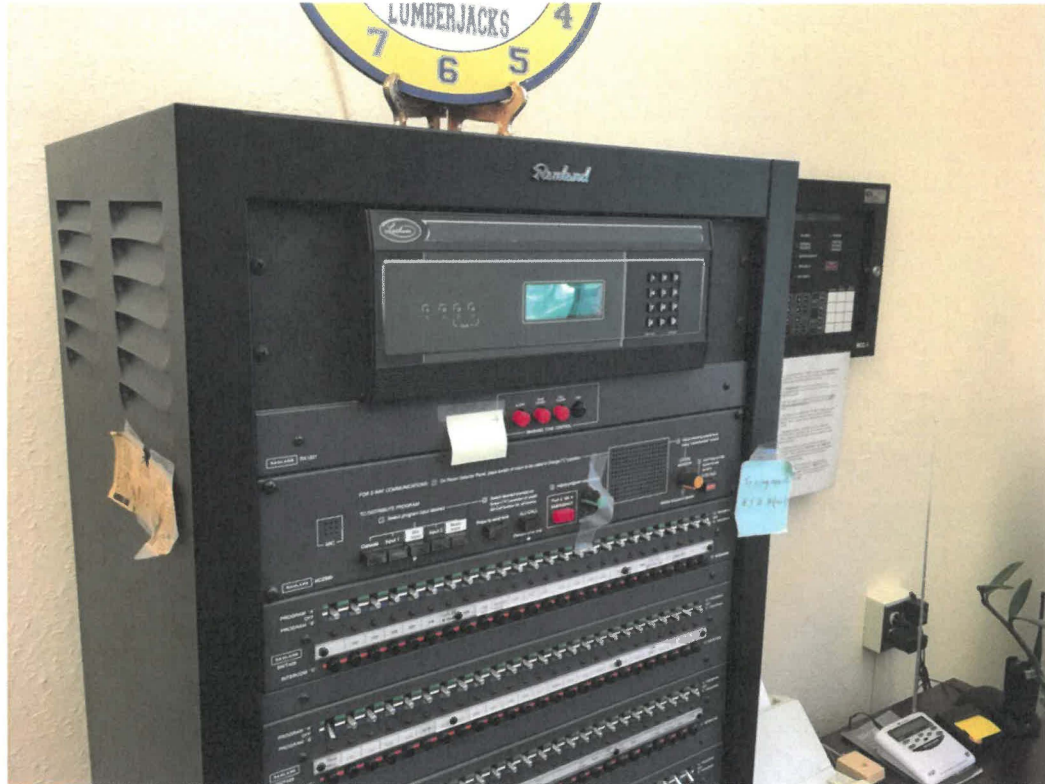
- The existing paging system is at the end of its useful life and should be replaced in its entirety. This older system was simply extended for the 2005 addition, so this work would be across the Junior High and High School.

| Paging System and Speakers | 178,238 | sf | The existing paging system has reached the end of it's life. Replacement parts and support are not available for the existing system. Existing speakers are outdated and some are also damaged throughout the building. It is recommended that a new paging system be provided for the entire building. This would include a new headend, new speakers, and new cabling. | 1 | \$ 0.75 | - | | X |

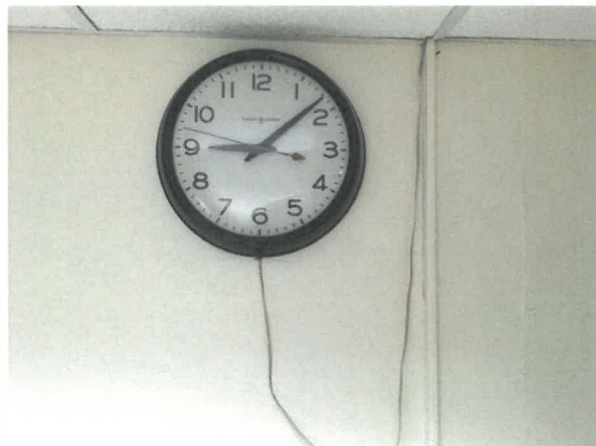
- The existing clocks are a mixture of digital clocks in the corridors and non-synchronous clocks in the classrooms and miscellaneous spaces. For overall better performance, it is recommended that a new, synchronous clock system be installed across the Junior High and High School.

| Clock System | 178,238 | sf | The existing clocks are a mixture of digital clocks in corridors and non-synchronous clocks in classrooms and misc. spaces. It is recommended the the entire building be provided with a synchronous clock system that is tied into other systems within the building. | 2 | \$ 0.40 | - | | X |

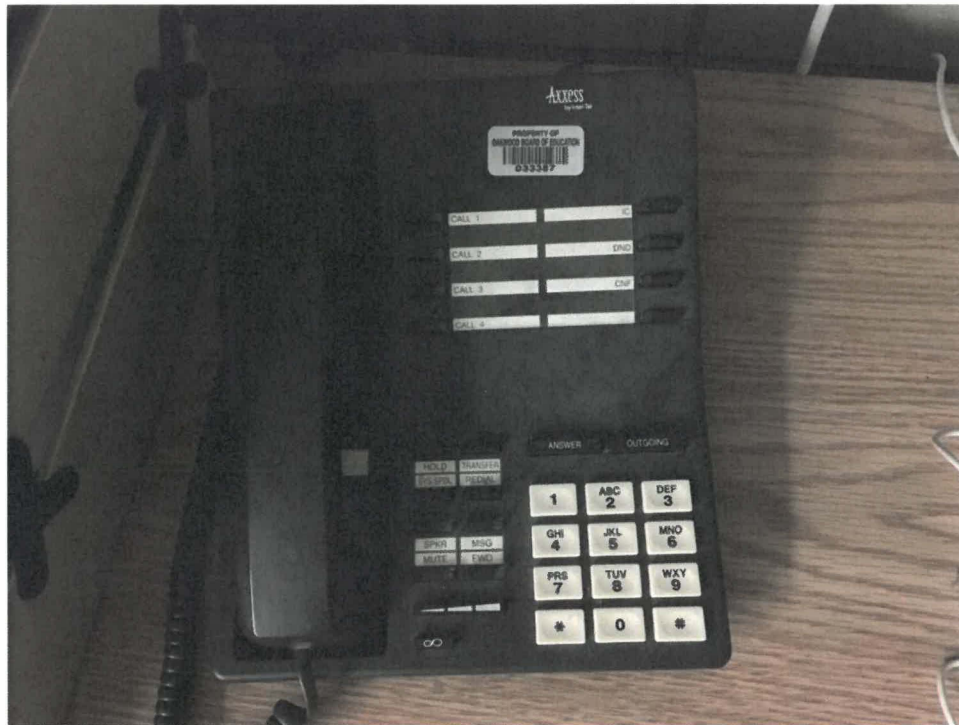
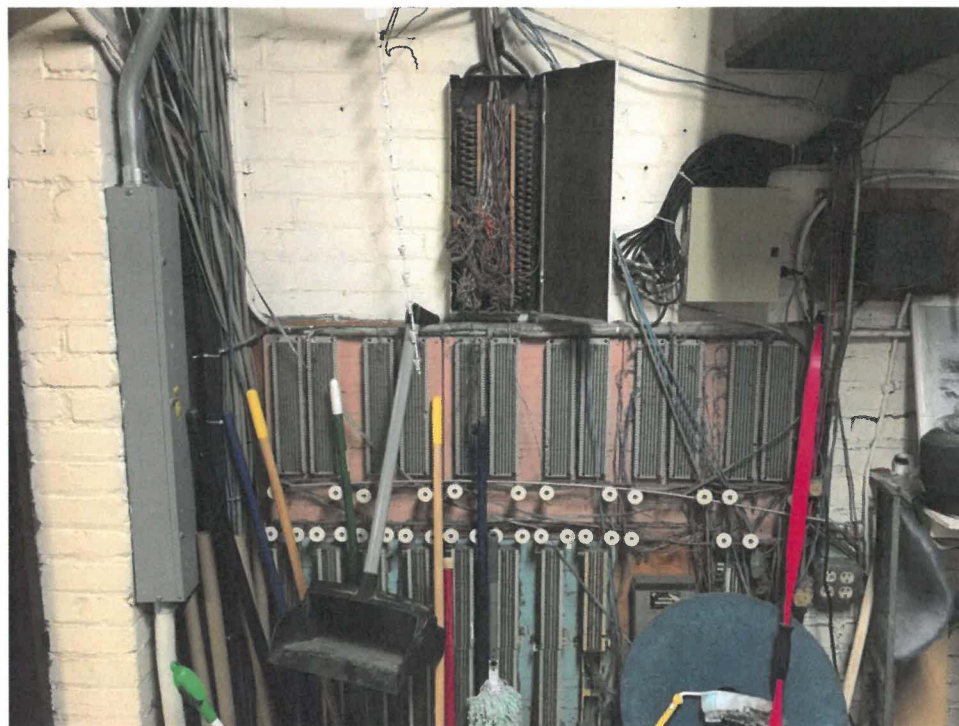
- The existing analog phone system has reached the end of its useful life. When a phone fails, only refurbished phones are available for replacement. A new IP phone system is recommended for replacement.

| Phone System and Phones | 90 | ea | The existing analog phone system has reached the end of it's life. When existing phones stop working, the only phones available for replacement with the existing system are refurbished ones. It is recommended that a new IP phone system be provided. This will include a new phone switch or managed system, and all new IP phones. | 1 | \$ 675.00 | 60,750 | X | |

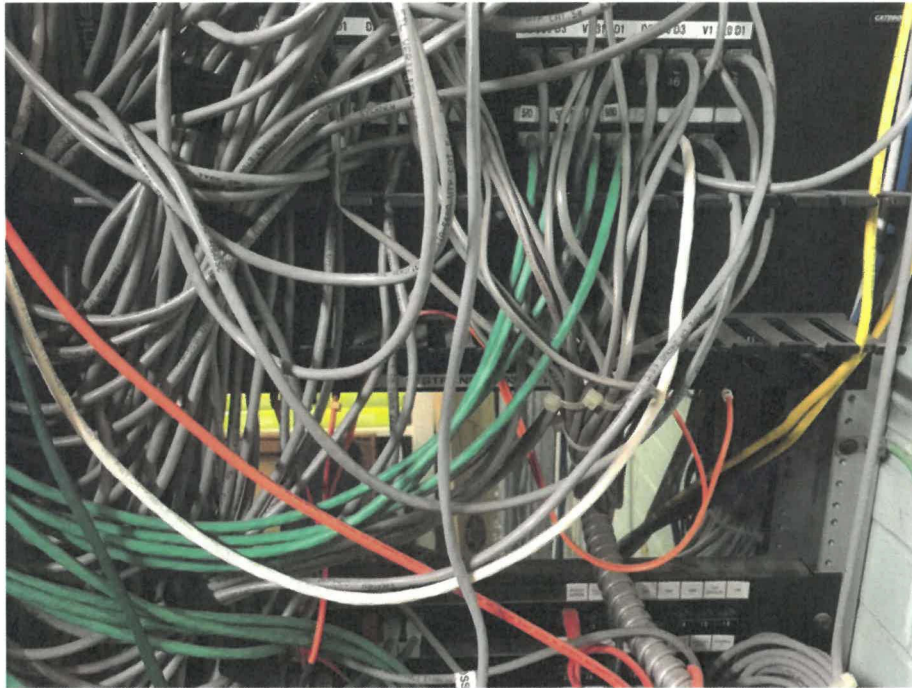
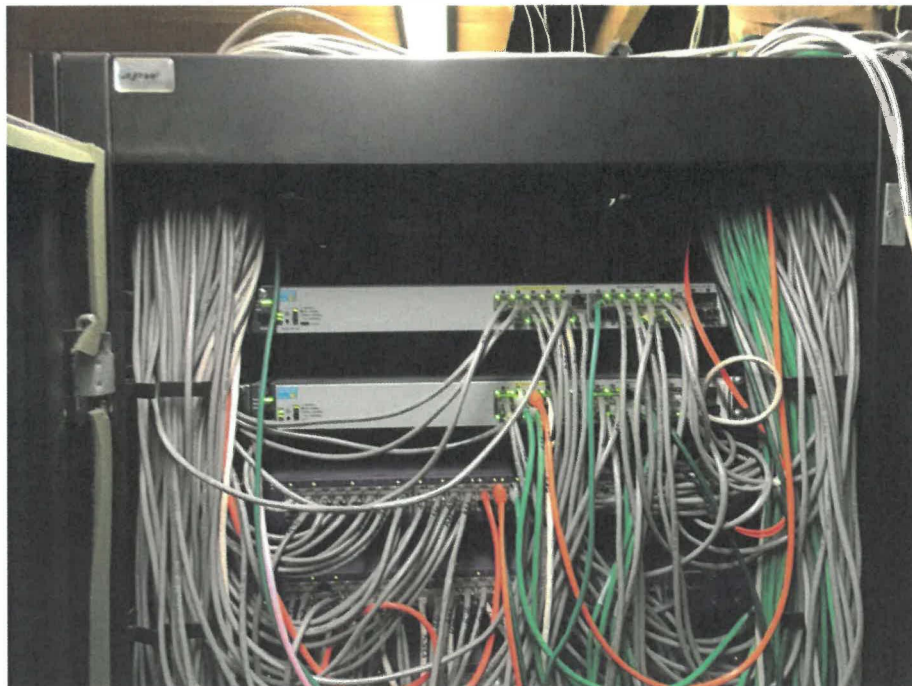
- The data cabling in the building is currently a mixture of Category 5, 5E and 6. There are locations in the building where the cabling is damaged. The type of cabling needed to increase the speed of the overall system to an effective 10Gb and the bandwidth is 6A. This upgrade includes cabling to faceplate connections and the wireless access points. Additional wireless devices will be able to access the network at an increased speed.

| Horizontal Cabling Infrastructure | 178,238 | sf | The data cabling in the building is currently a mixture of Category 5, SE, and 6. There are many existing locations where the cabling appears to be damaged. It is recommended that the cabling to support wireless access points be upgdgraded to Category 6A to support higher bandwidth. This will allow the wireless network to support more wireless devices at higher speeds. It is also recommended that all the Category 5 and 5e cabling in the building be replaced with Category 6A cabling. This will also support higher bandwidth. | 2 | \$ 1.80 | 320,828 | X | |

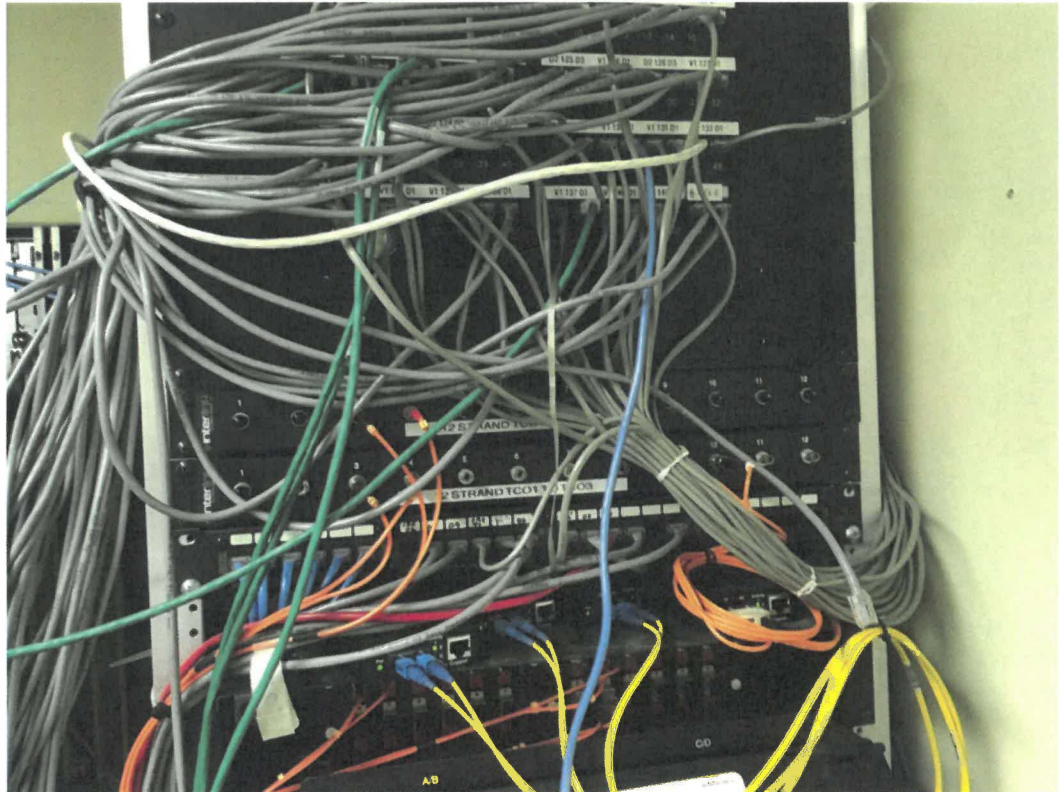
- The existing fiber backbone is currently 62.5 multi-mode fiber optic cable. It is capable of support up to a 1Gb backbone for the network. It is recommended that this be upgraded to a 50 micron multi-mode fiber optic cable that will allow up to a 10Gb backbone. The speed of the network is needed with the increase use of wireless and computer technology in the school curriculum.

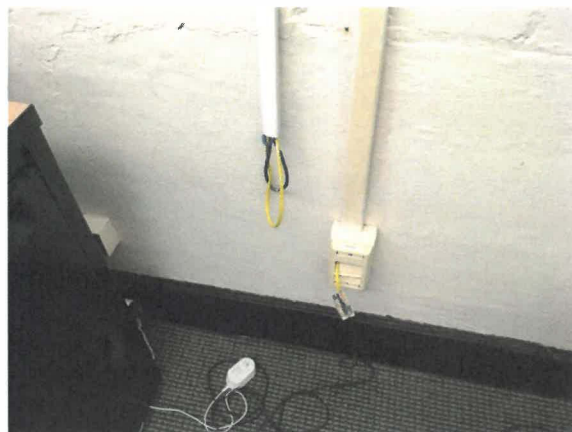
- The existing raceway and junction boxes for many of the data locations have been damaged. Raceway is torn from the wall, boxes are hanging by the data cables, etc. With the recommendation of new cabling throughout, it is also recommended the raceway system be repaired and replaced throughout.

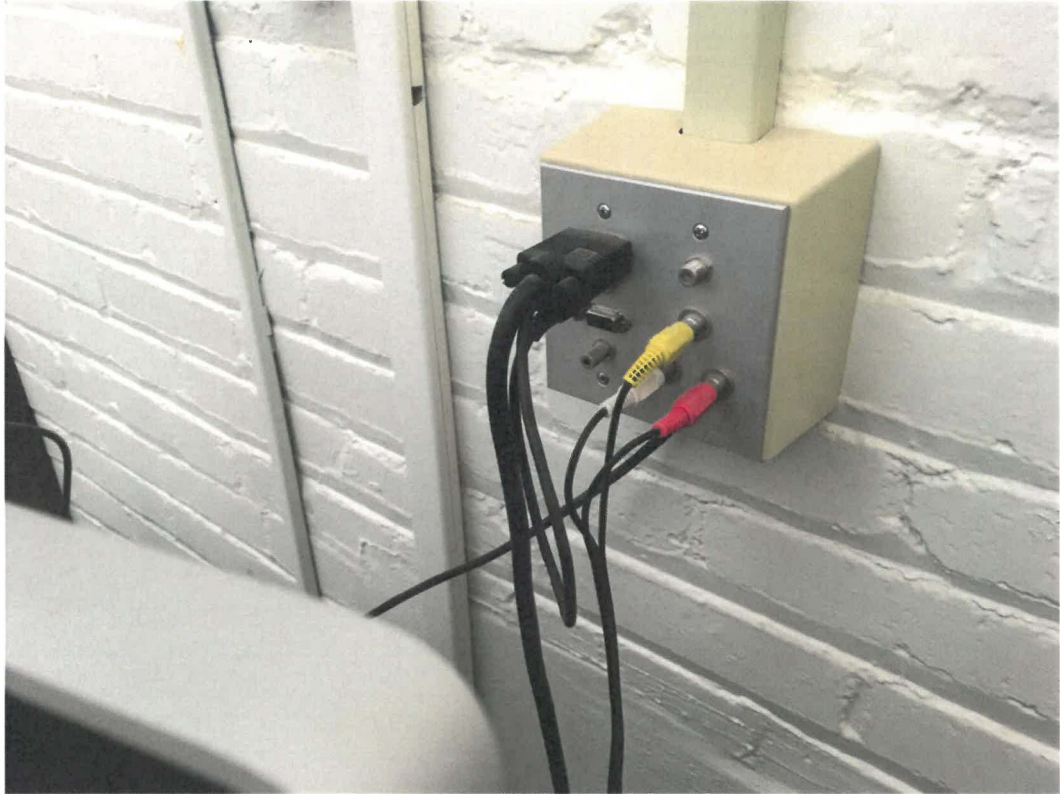
- The existing AV cabling in the classrooms is analog VGA type. As the classroom projectors are replaced (currently about 50% of the projectors are replaced) along with new computer updates for staff, only an HDMI cabling solution will work.

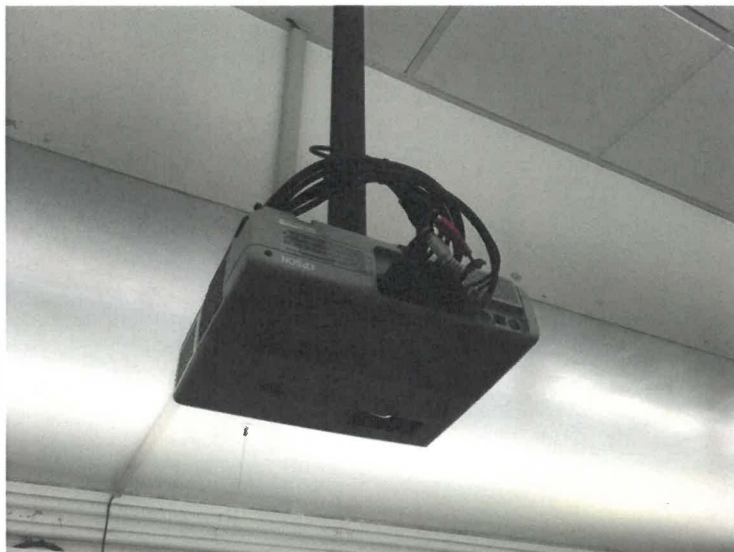
- It is recommended that the remaining 50% of the older LCD projectors be replaced with new LED ceiling mounted projectors.

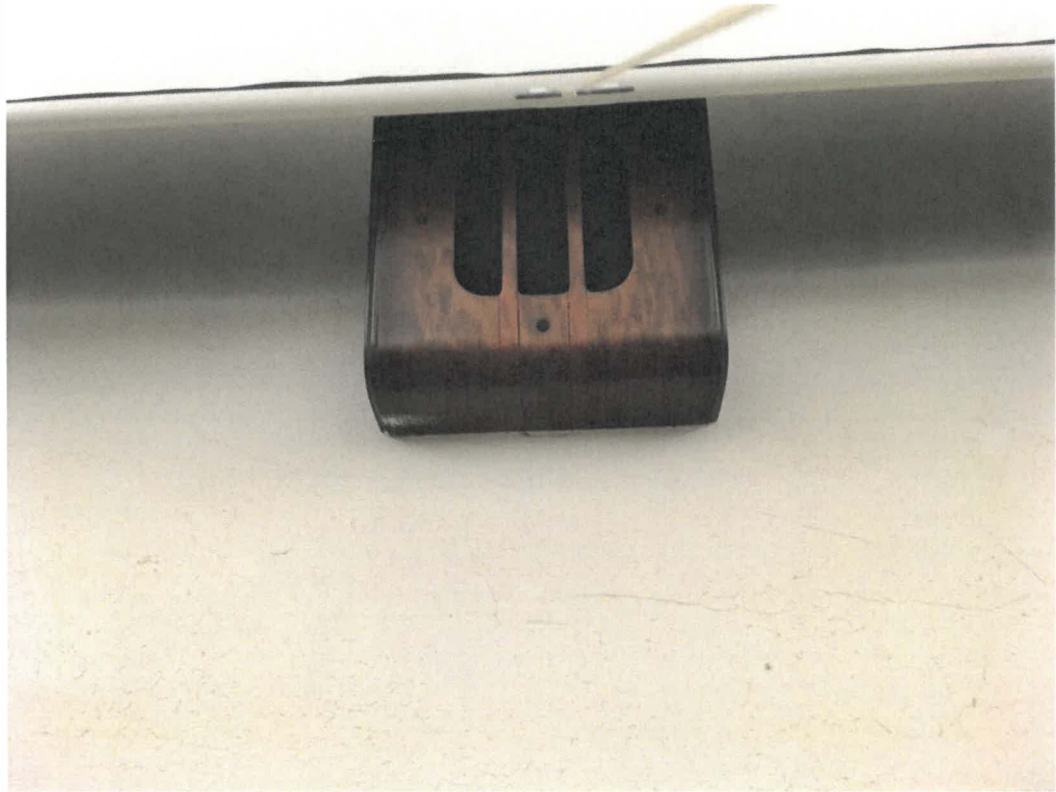
- The existing sound system in the classroom consists of a single speaker that is typically mounted on the teaching wall. The speaker system has reached the end of its useful life. It is recommended that a new system that includes a small amplifier and ceiling speakers be installed as the replacement system to be available for audio needs from the teachers' computer or student devices.

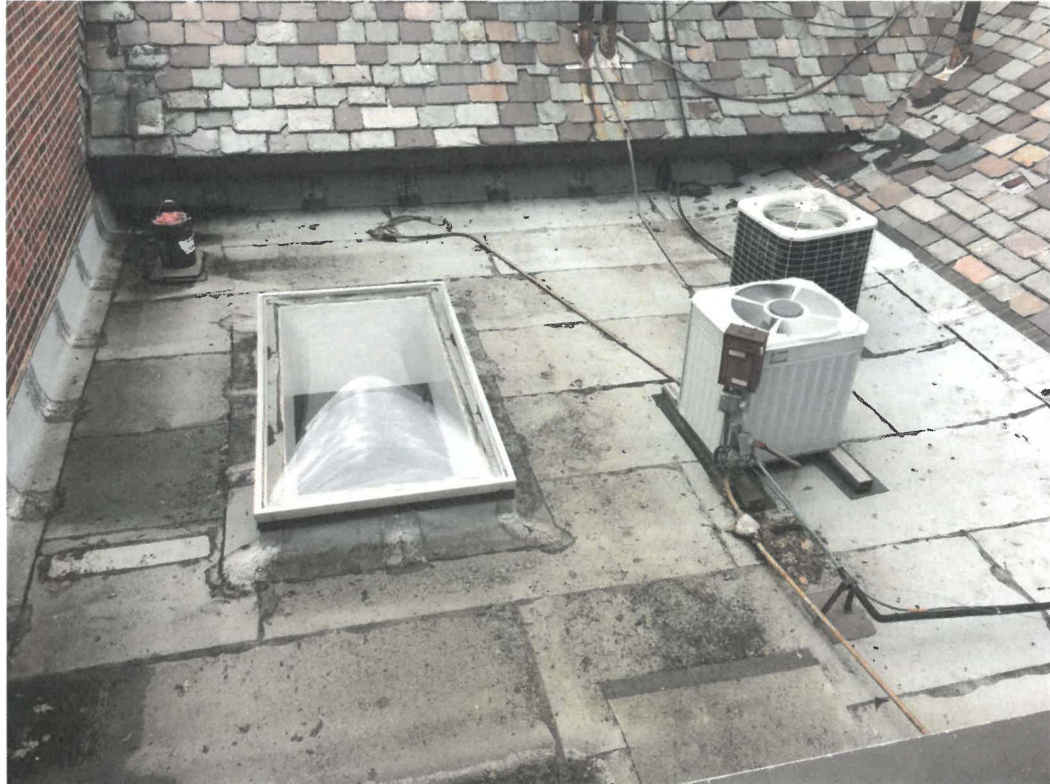
- The gym roof (single-ply membrane, fully adhered root system) was replaced in approximately 1994 and is in need of replacement.
- The original slate tile is over 80 years old. Individual tiles are brittle, cracked, broken, and missing throughout the roof area. Nails are reported as brittle and breaking causing tiles to come loose. Flashings appear worn throughout and are staining tiles at drip areas. Complete replacement/upgrade is recommended. The slate installed in 2005 is in satisfactory condition.

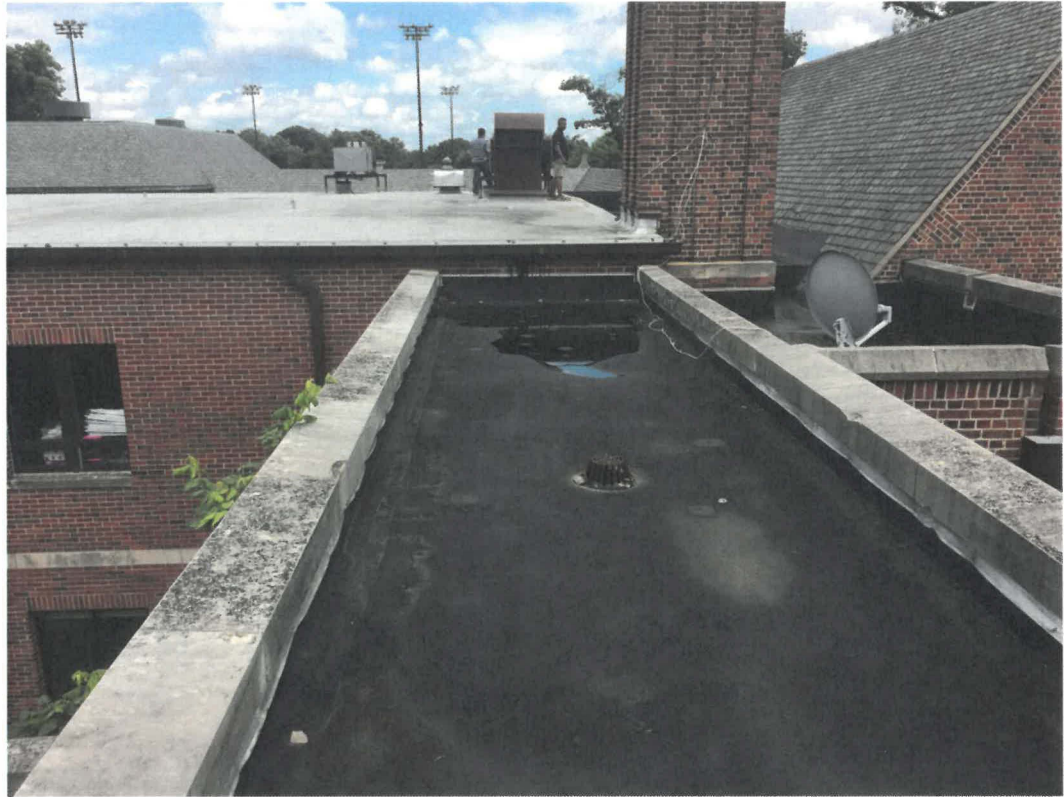
- The built-up roofing area is very worn, past its useful life and in need of replacement. It is recommended that the system be replaced with a single-ply membrane roofing that matches the same roofing type on the facility.

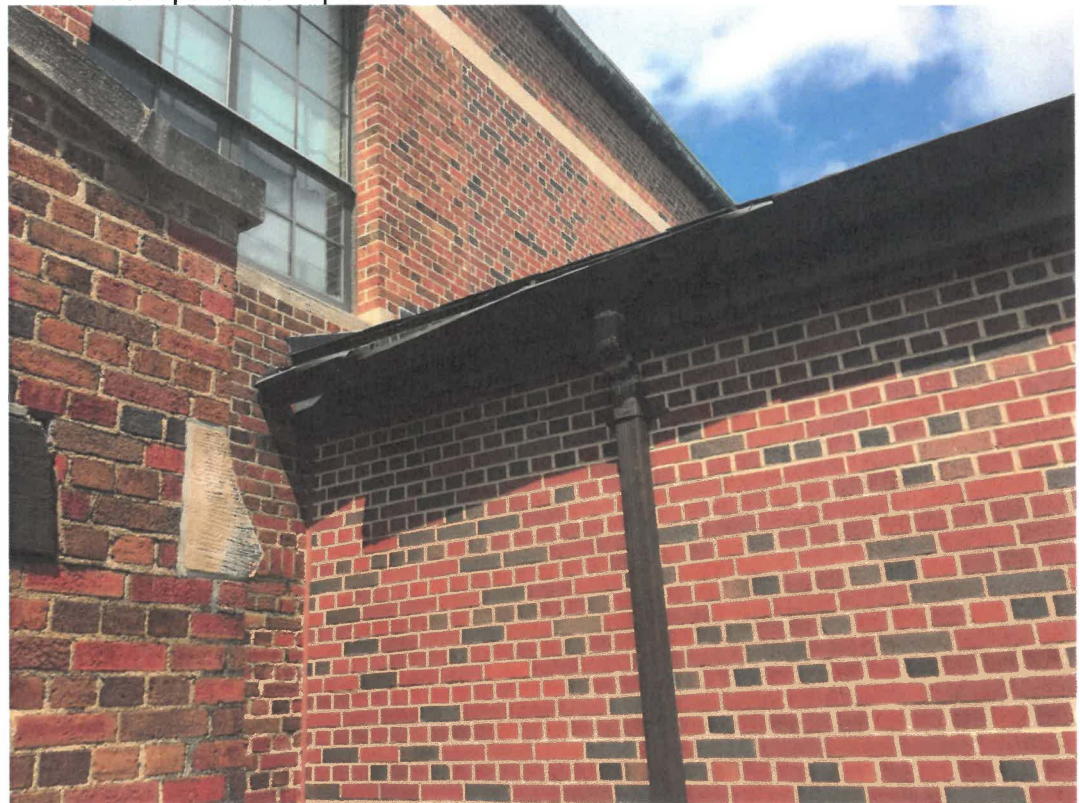
- It is estimated that 5-10% of the miscellaneous gutters and downspouts be repaired or replaced.

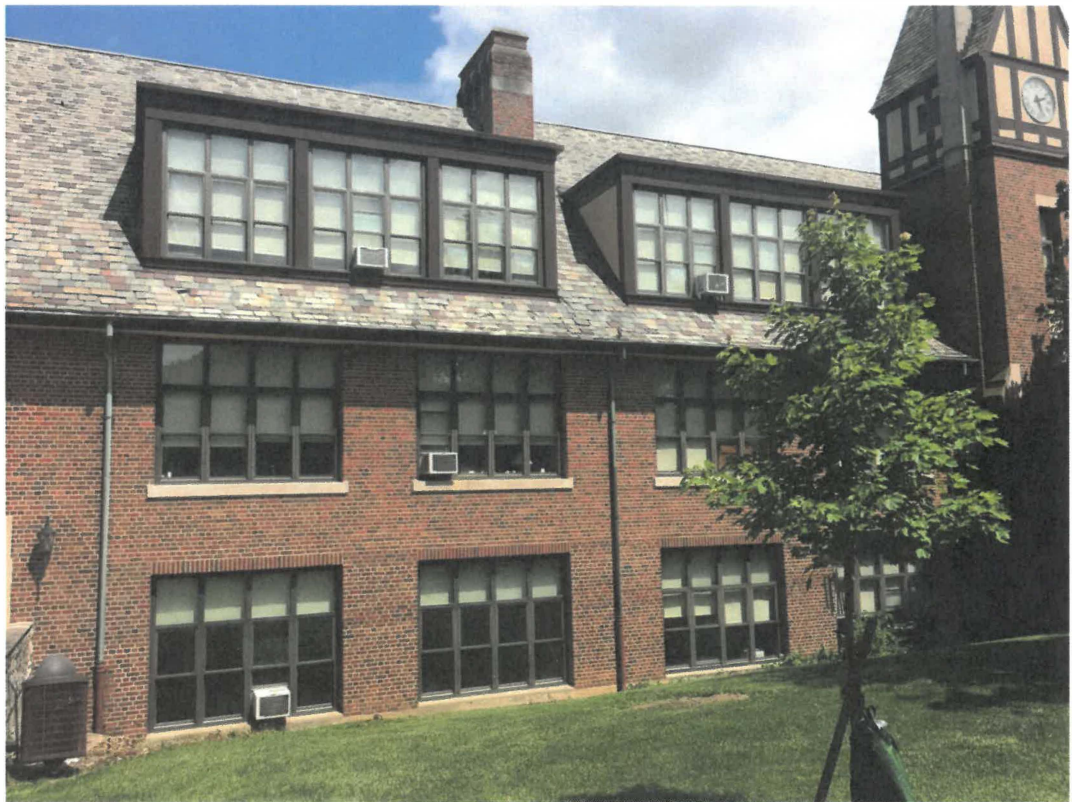
- Single-ply membrane roofing is in good condition and will not require replacing.
- The original slate tile is over 80 years old. Individual tiles are brittle, cracked, broken, and missing throughout the roof area. Nails are reported as brittle and breaking causing tiles to come loose. Flashings appear worn throughout and are staining tiles at drip areas. Complete replacement/upgrade is recommended. The slate installed in 2005 is in satisfactory condition.
