Oakwood Junior High / High School

Oakwood City Schools
Oakwood, Ohio

Technical Building Assessment Report

September 4, 2018

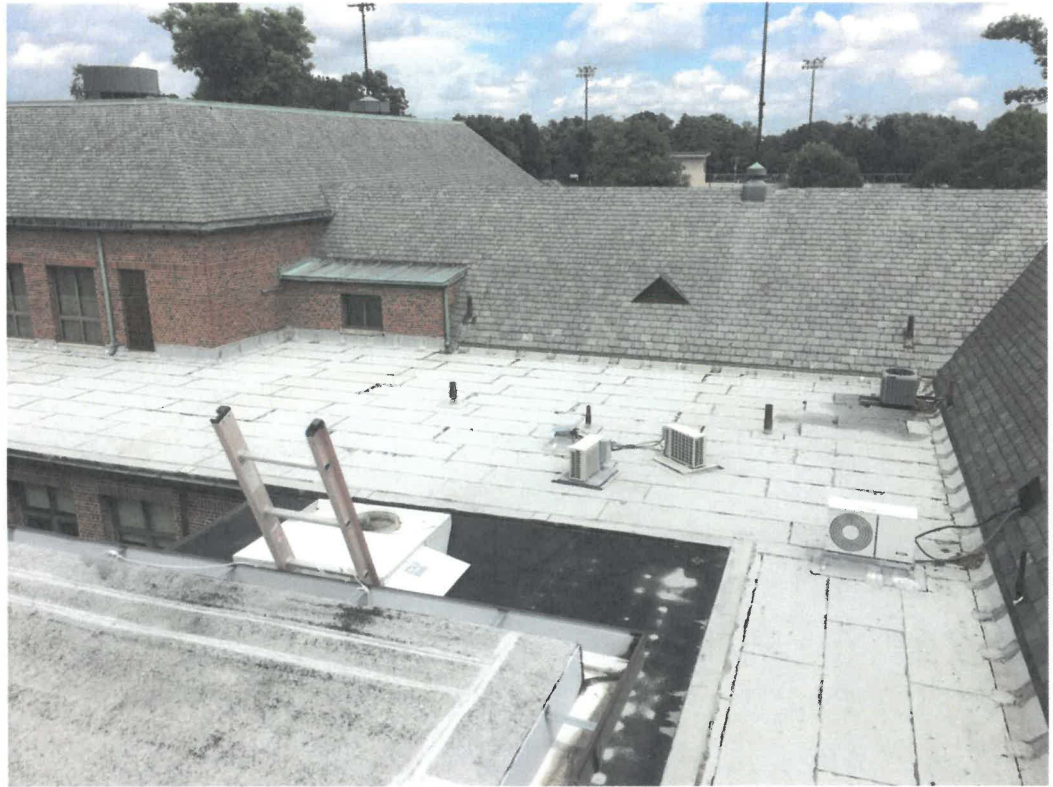
- The built-up roofing area is very worn, past its useful life and in need of replacement. It is recommended that the system be replaced with a single-ply membrane roofing that matches the same roofing type on the facility.

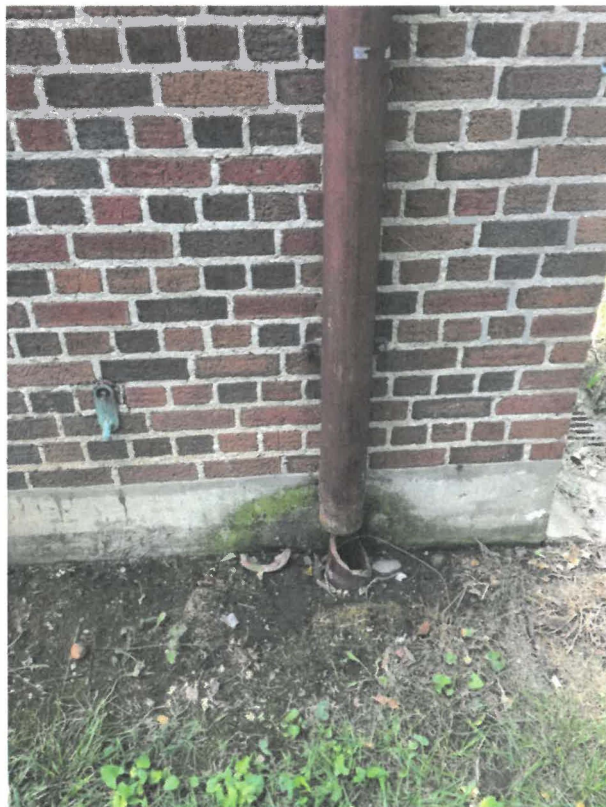
- It is estimated that 5-10% of the miscellaneous gutters and downspouts be repaired or replaced.
