September 6, 2018

Re: **Smith Elementary, Harman Elementary and Oakwood Junior/Senior High School** - 2/3 Waiver Request

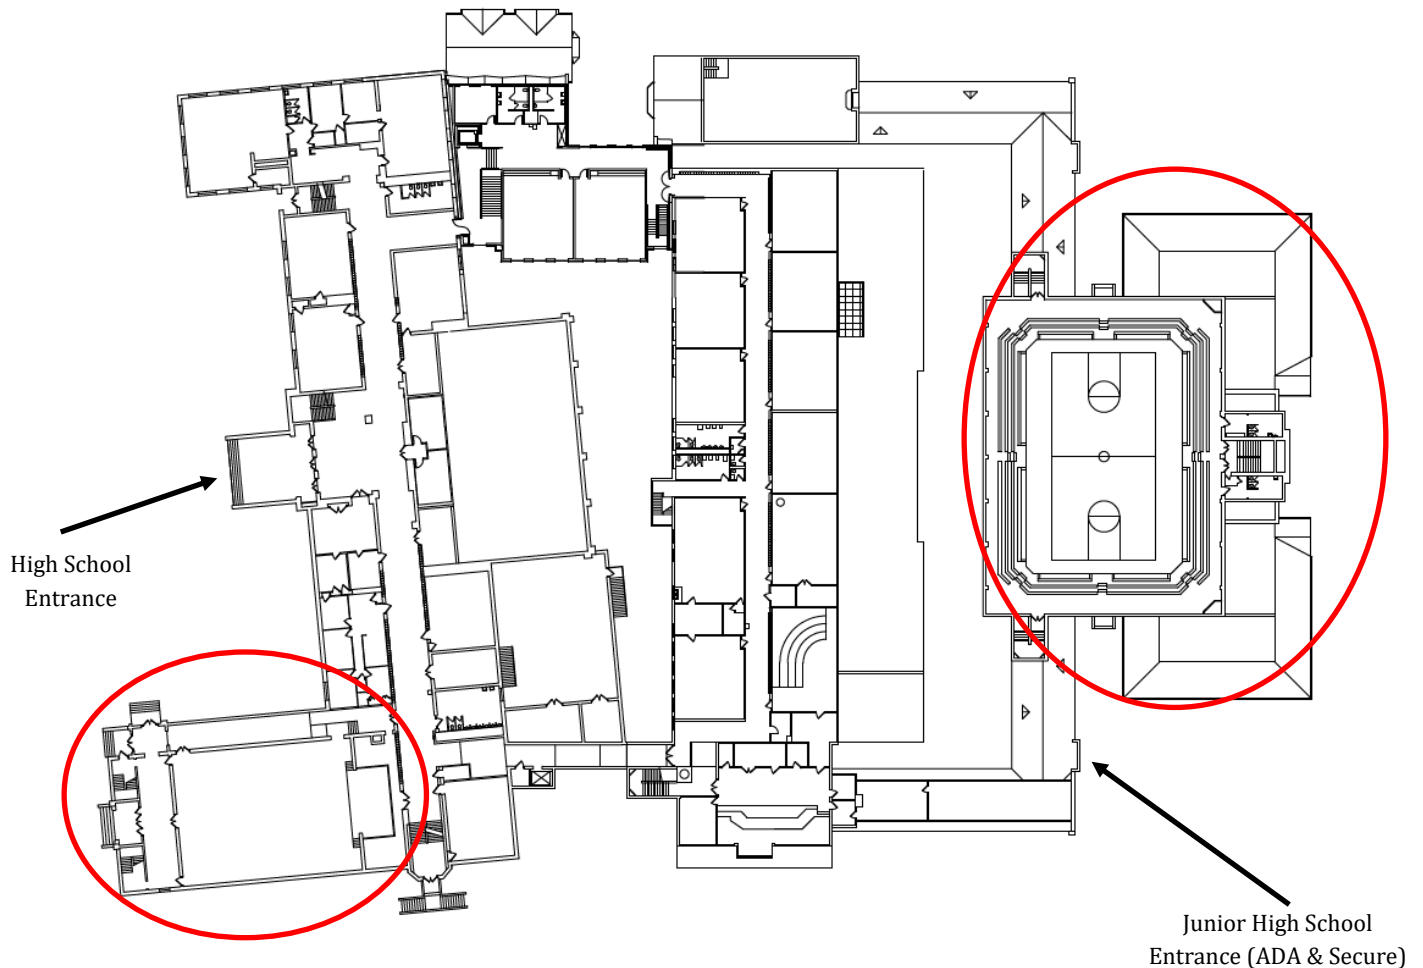
It would be ideal to have a secured/ADA entrance on the high school side of the building near their administrative offices.

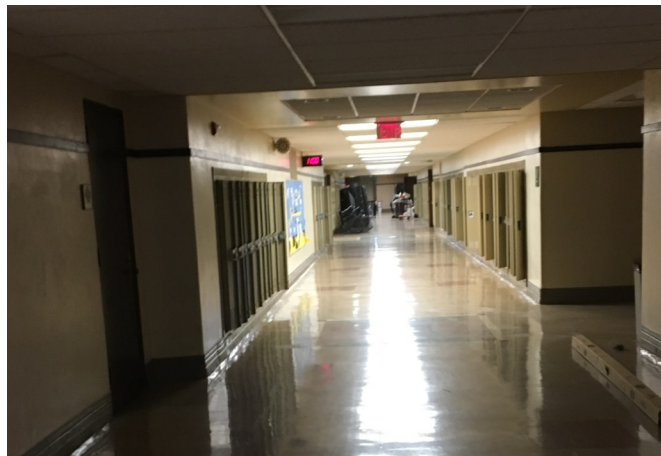
Some door alcoves would need to be adjusted to be ADA accessible. Throughout the building, there are a variety of door alcoves. The building does contain ADA restroom facilities as well as an elevator and an accessible stair by way of chair lift. Corridors are sufficiently wide enough for ADA accessibility.

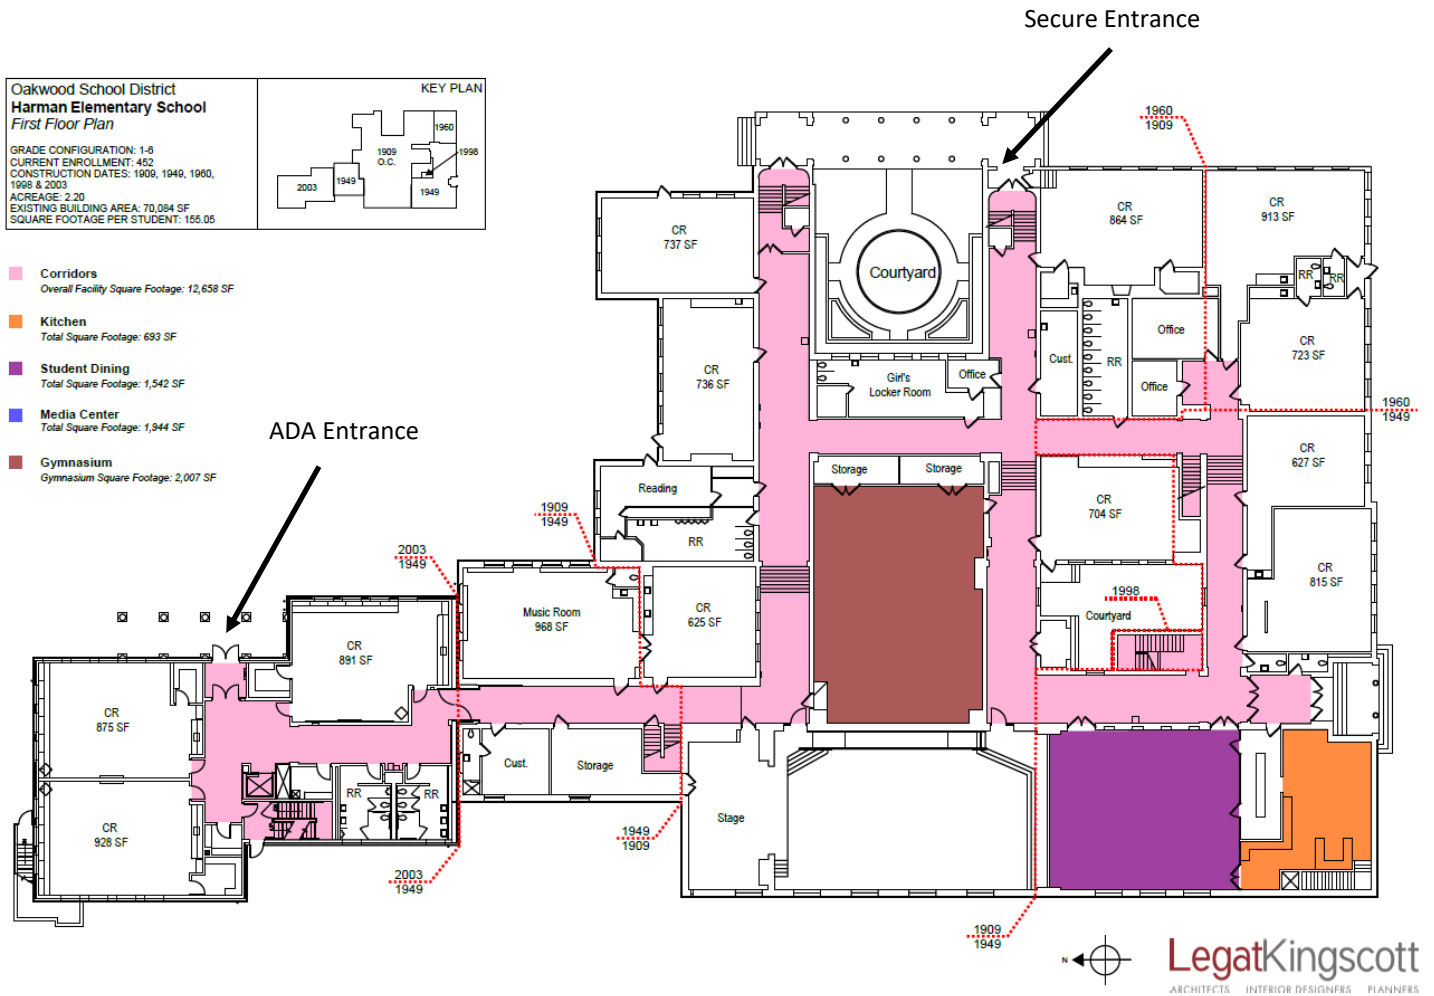
The building does have a secure entrance, but it is not ADA. As such, visitors needing to get to the office, would be required to go through the building by way of the 2003 addition.

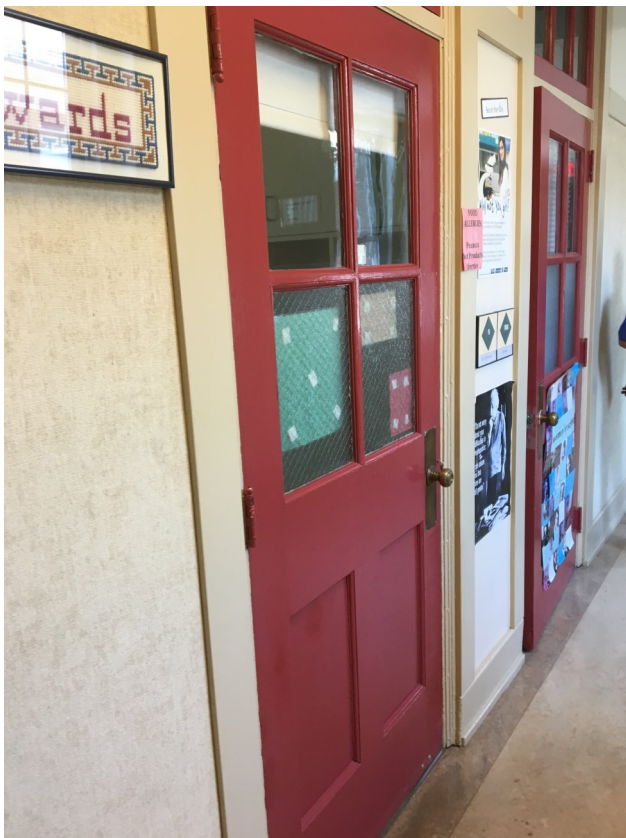
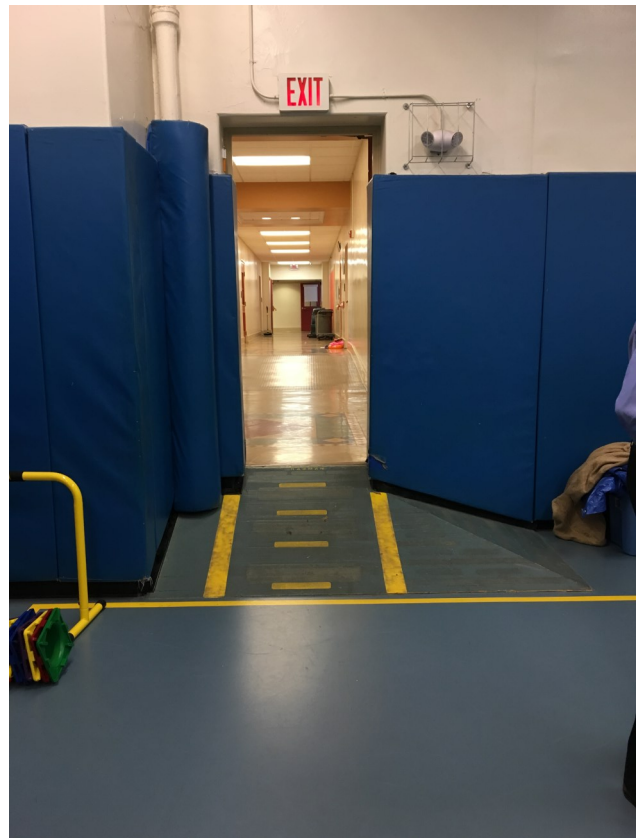
Some door alcoves may need to be adjusted for ADA, but most doors are flush with corridor walls. There is a ramp in the gym immediately inside the door that should be adjusted for ADA. The building does contain ADA restroom facilities as well as an elevator and an accessible stair by way of chair lift. Corridors are sufficiently wide enough for ADA accessibility.

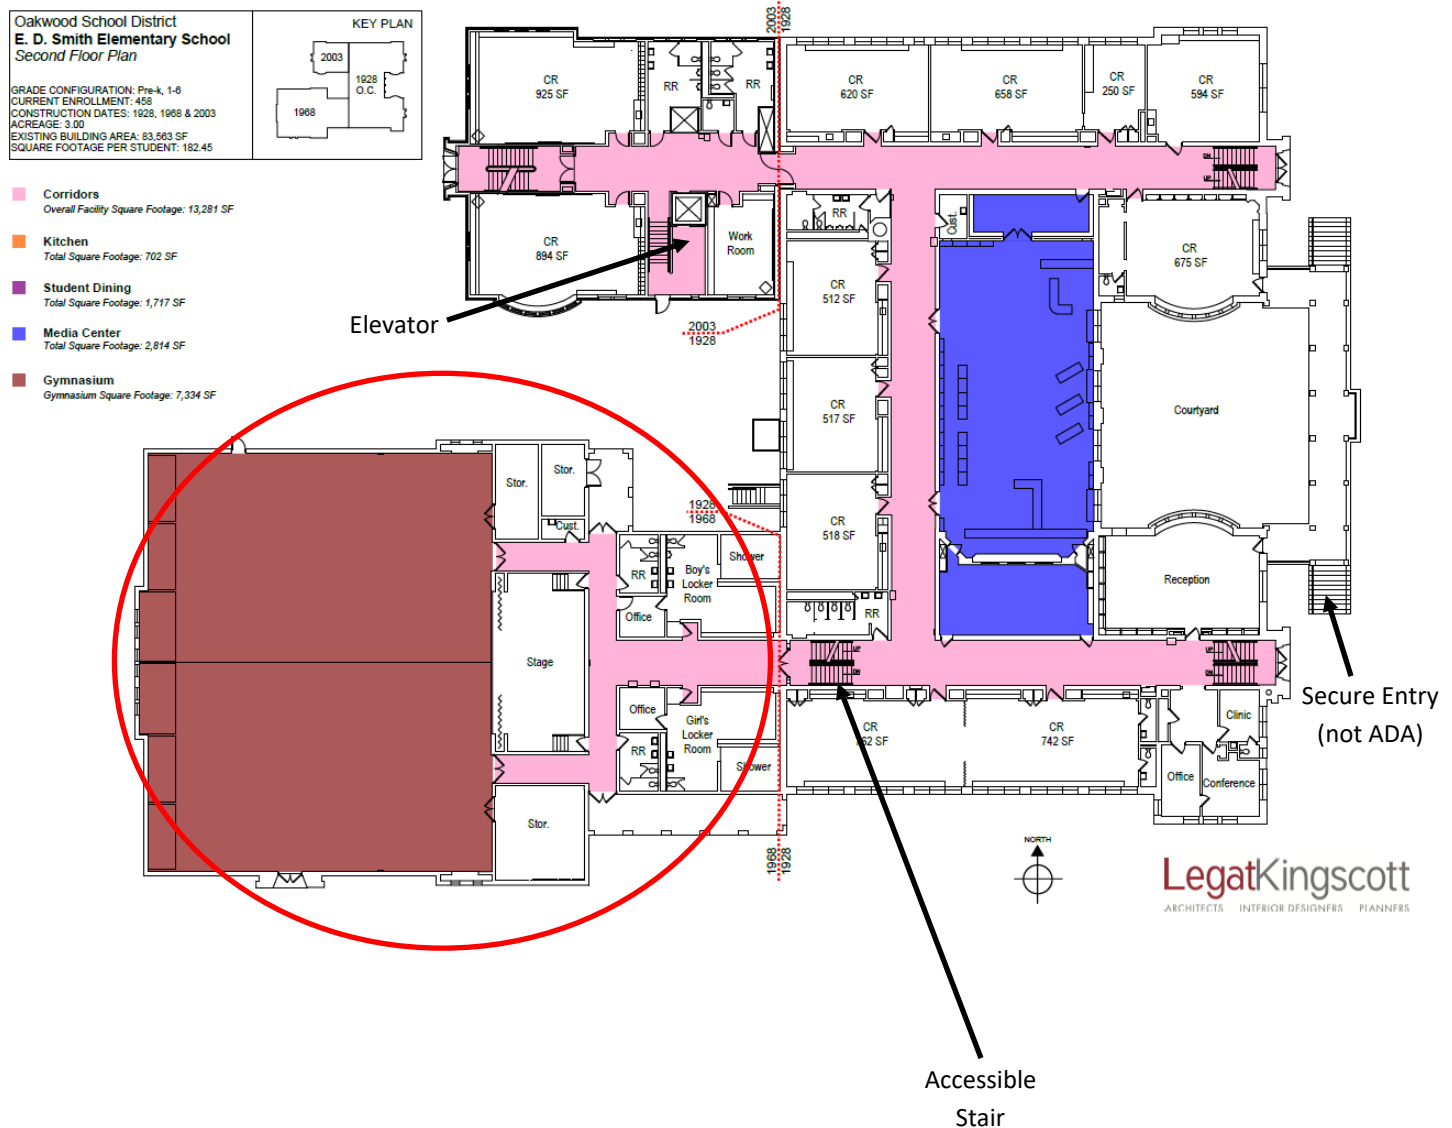
The building does have a secure entrance, but it is not ADA. As such, visitors needing to get to the office, would be required to go through the building by way of either the addition (elevator) or the gym area (stair lift).

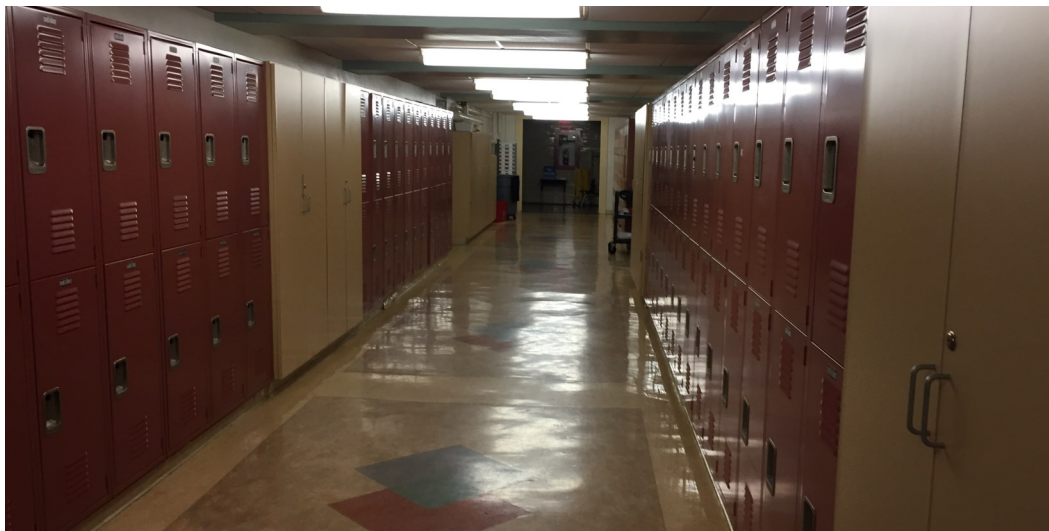
Some door alcoves would need to be adjusted to be ADA accessible. Throughout the building, there are a variety of door alcoves. Building does contain ADA restroom facilities as well as an elevator and an accessible stair by way of chair lift. Corridors are sufficiently wide enough for ADA accessibility.

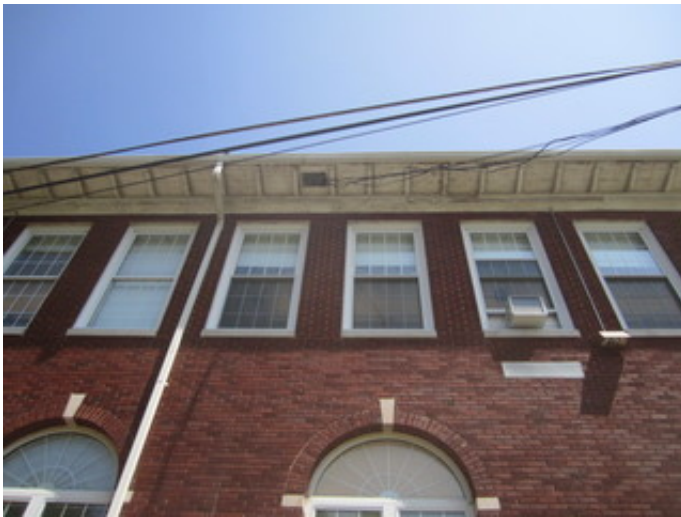
Soffit at 1949 South Elevation

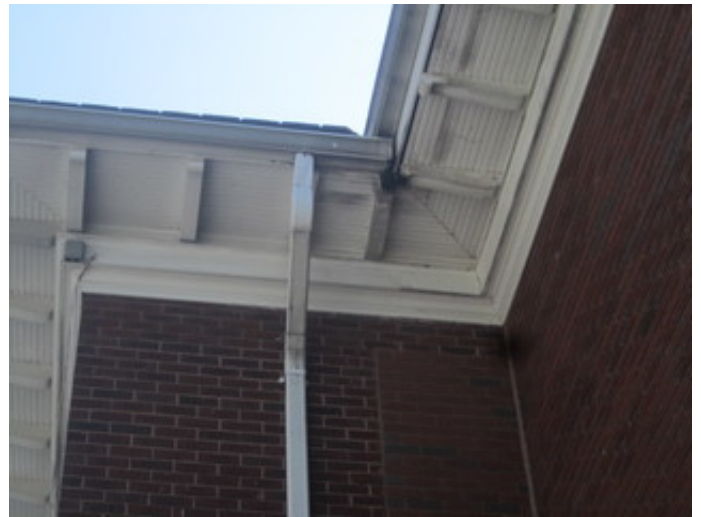
Soffit at 1949 and 1909 Intersection

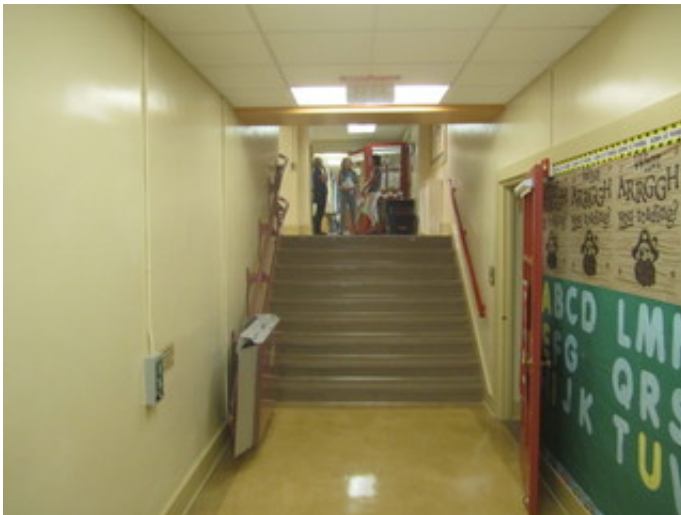
Existing Chair Lift

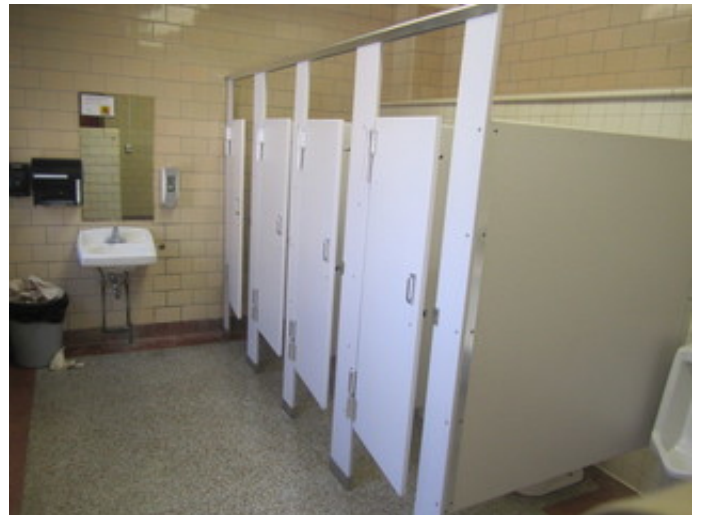
Typical Restroom in 1909 Original Construction

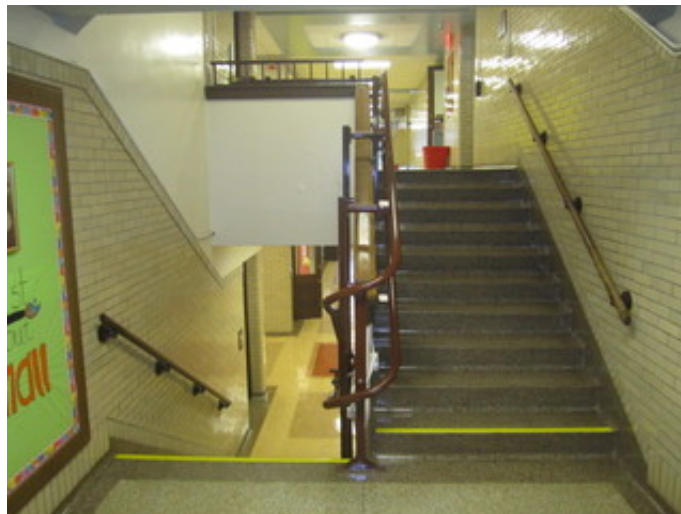
Existing Chair Lift

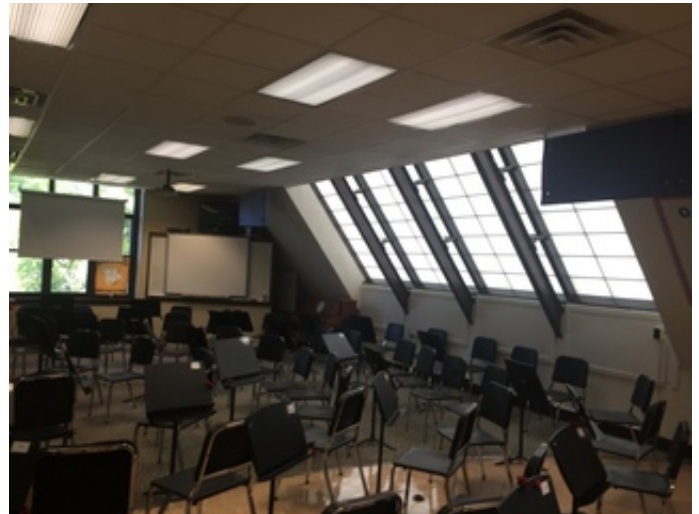
Orchestra Room Roof Structure on Third Floor of 1927 Original Construction
