**AHERA
ASBESTOS ASSESSMENT
OAKWOOD SENIOR & JUNIOR HIGH SCHOOL
1200 FAR HILLS AVENUE
OAKWOOD, OHIO 45419**

December 7, 2018

18-9929

**ERAtch ENVIRONMENTAL, INC.
ASBESTOS ASSESSMENT TEAM
OAKWOOD SENIOR & JUNIOR HIGH SCHOOL
1200 FAR HILLS AVENUE
OAKWOOD, OHIO 45419**

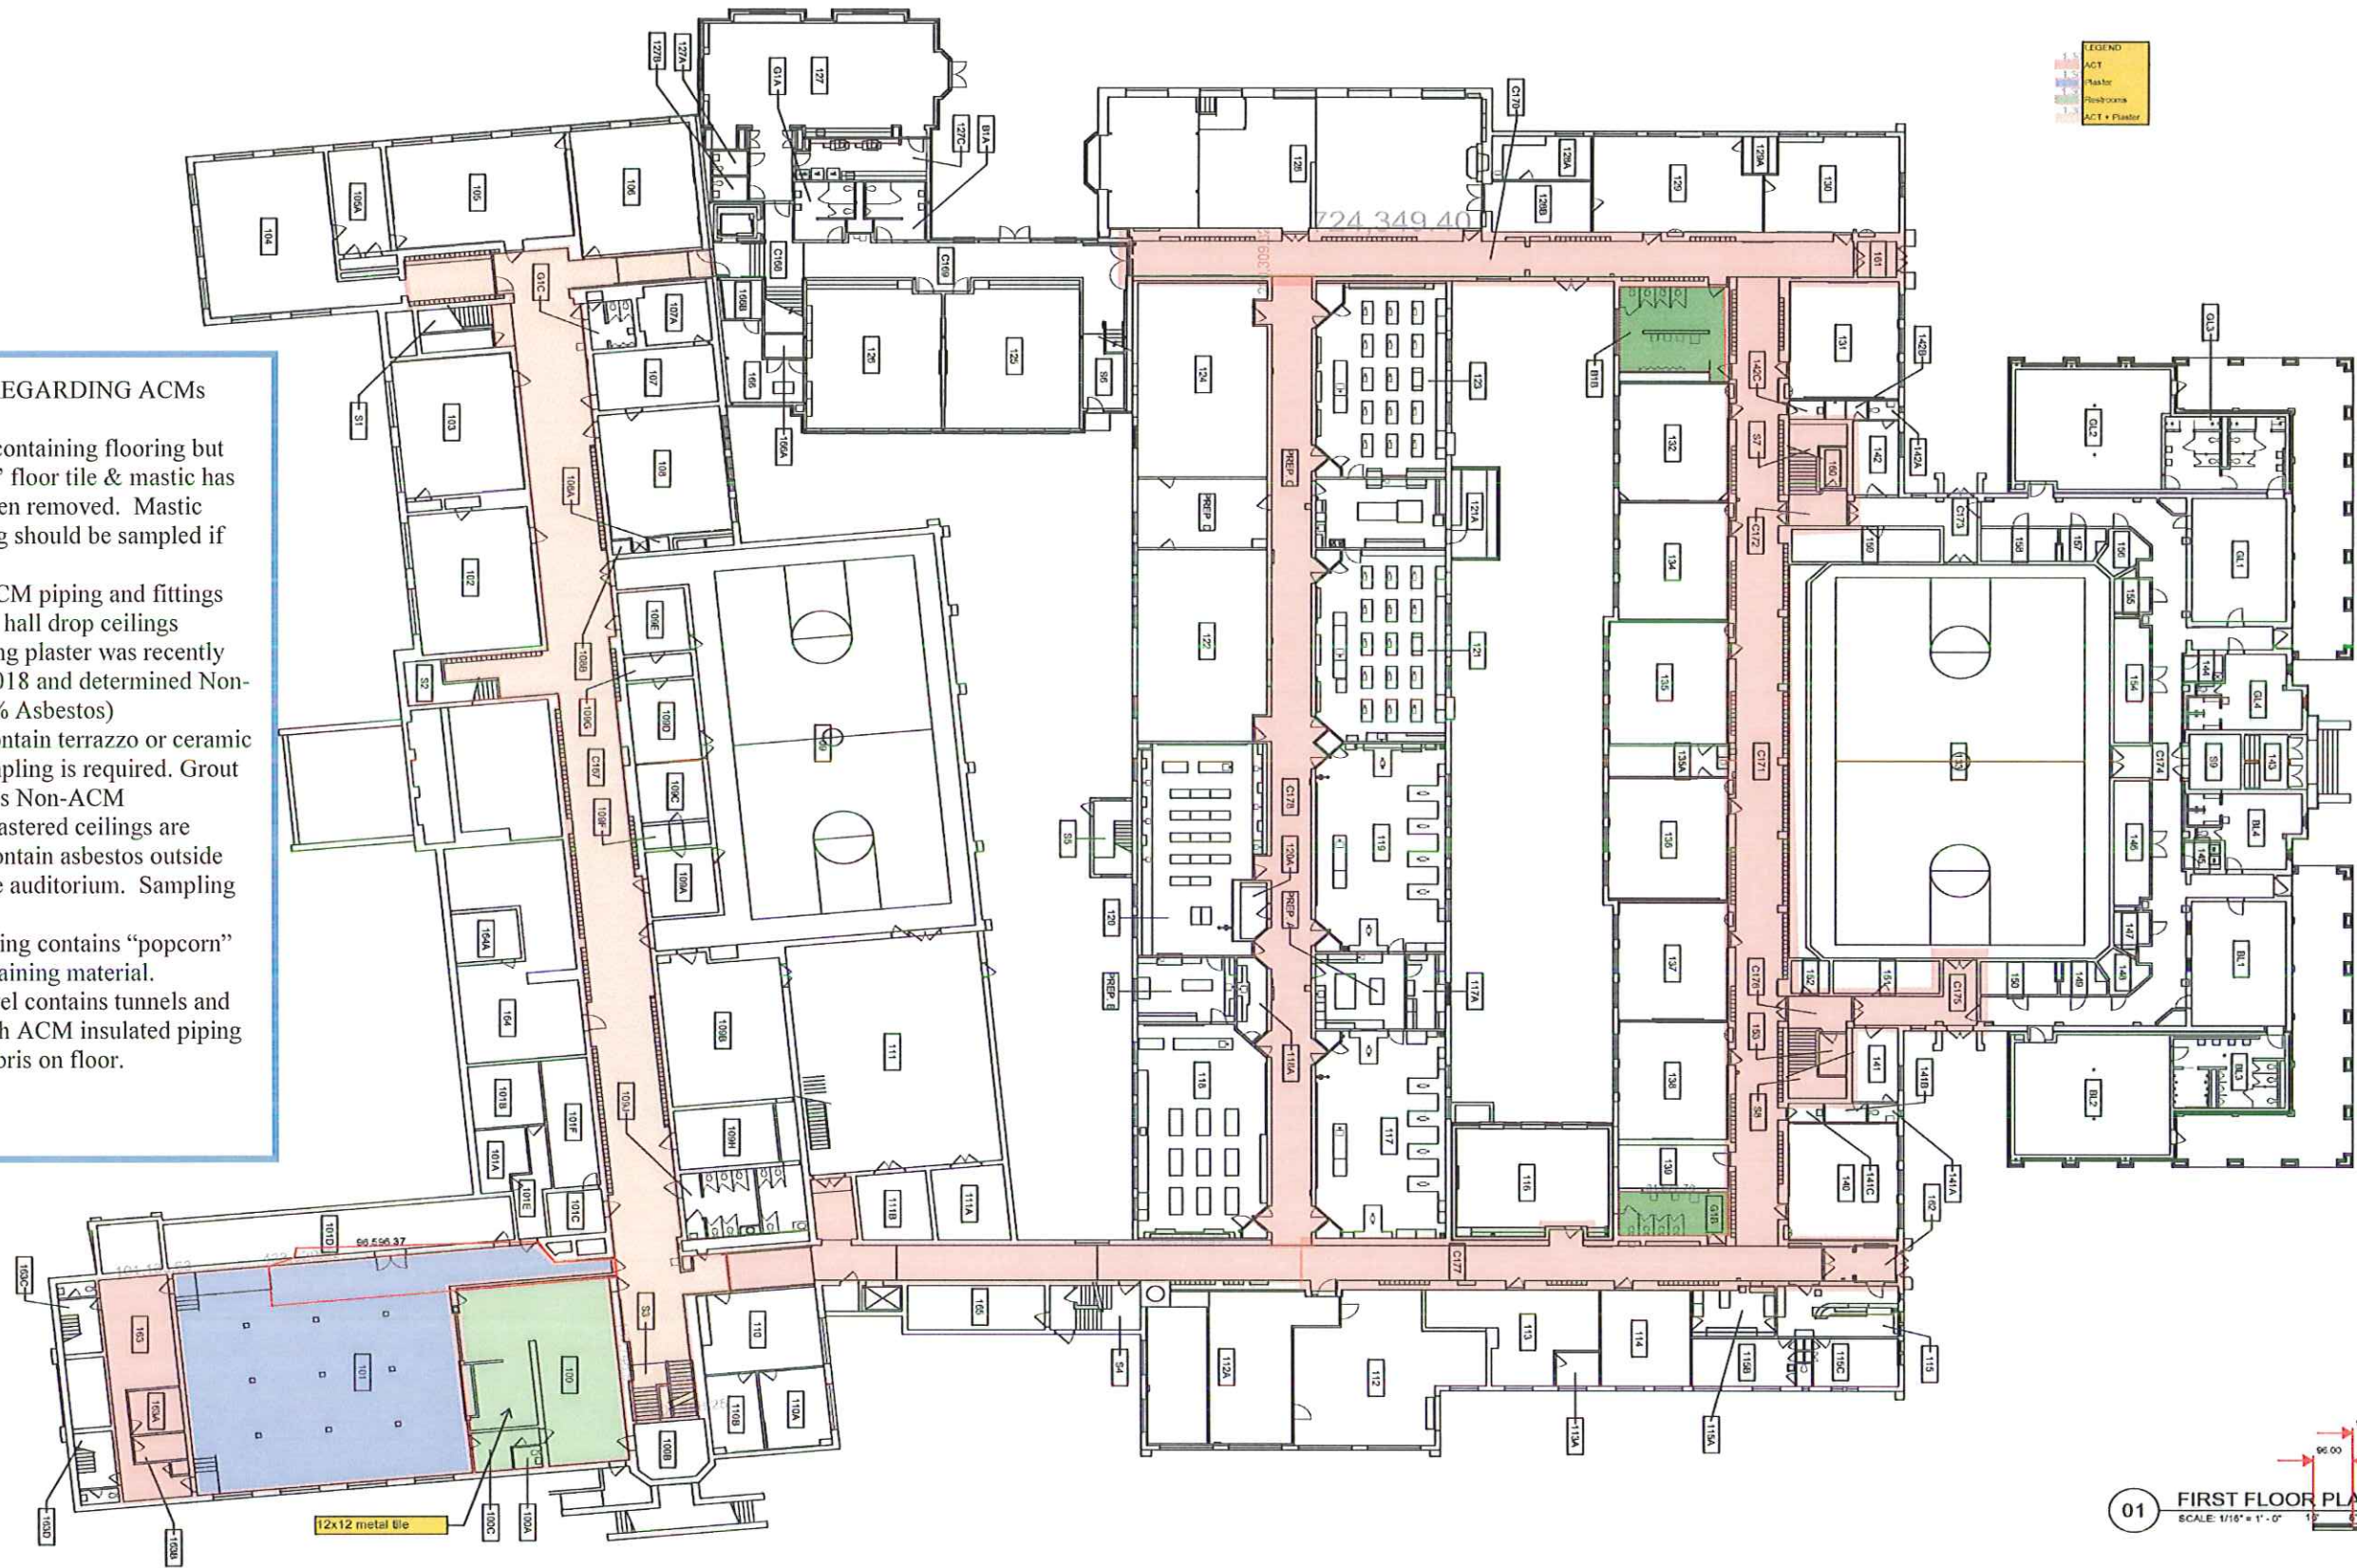
- GENERAL NOTES REGARDING ACMs
1. All asbestos containing flooring but kitchen 9"x9" floor tile & mastic has reportedly been removed. Mastic under flooring should be sampled if found.
 2. No known ACM piping and fittings are above the hall drop ceilings
 3. Wall & Ceiling plaster was recently sampled in 2018 and determined Non-ACM (< 1.0% Asbestos)
 4. Restrooms contain terrazzo or ceramic flooring. Sampling is required. Grout on tile walls is Non-ACM
 5. Acoustical plastered ceilings are reported to contain asbestos outside and inside the auditorium. Sampling is required.
 6. Cafeteria ceiling contains "popcorn" asbestos containing material.
 7. Basement level contains tunnels and ductwork with ACM insulated piping and ACM debris on floor.

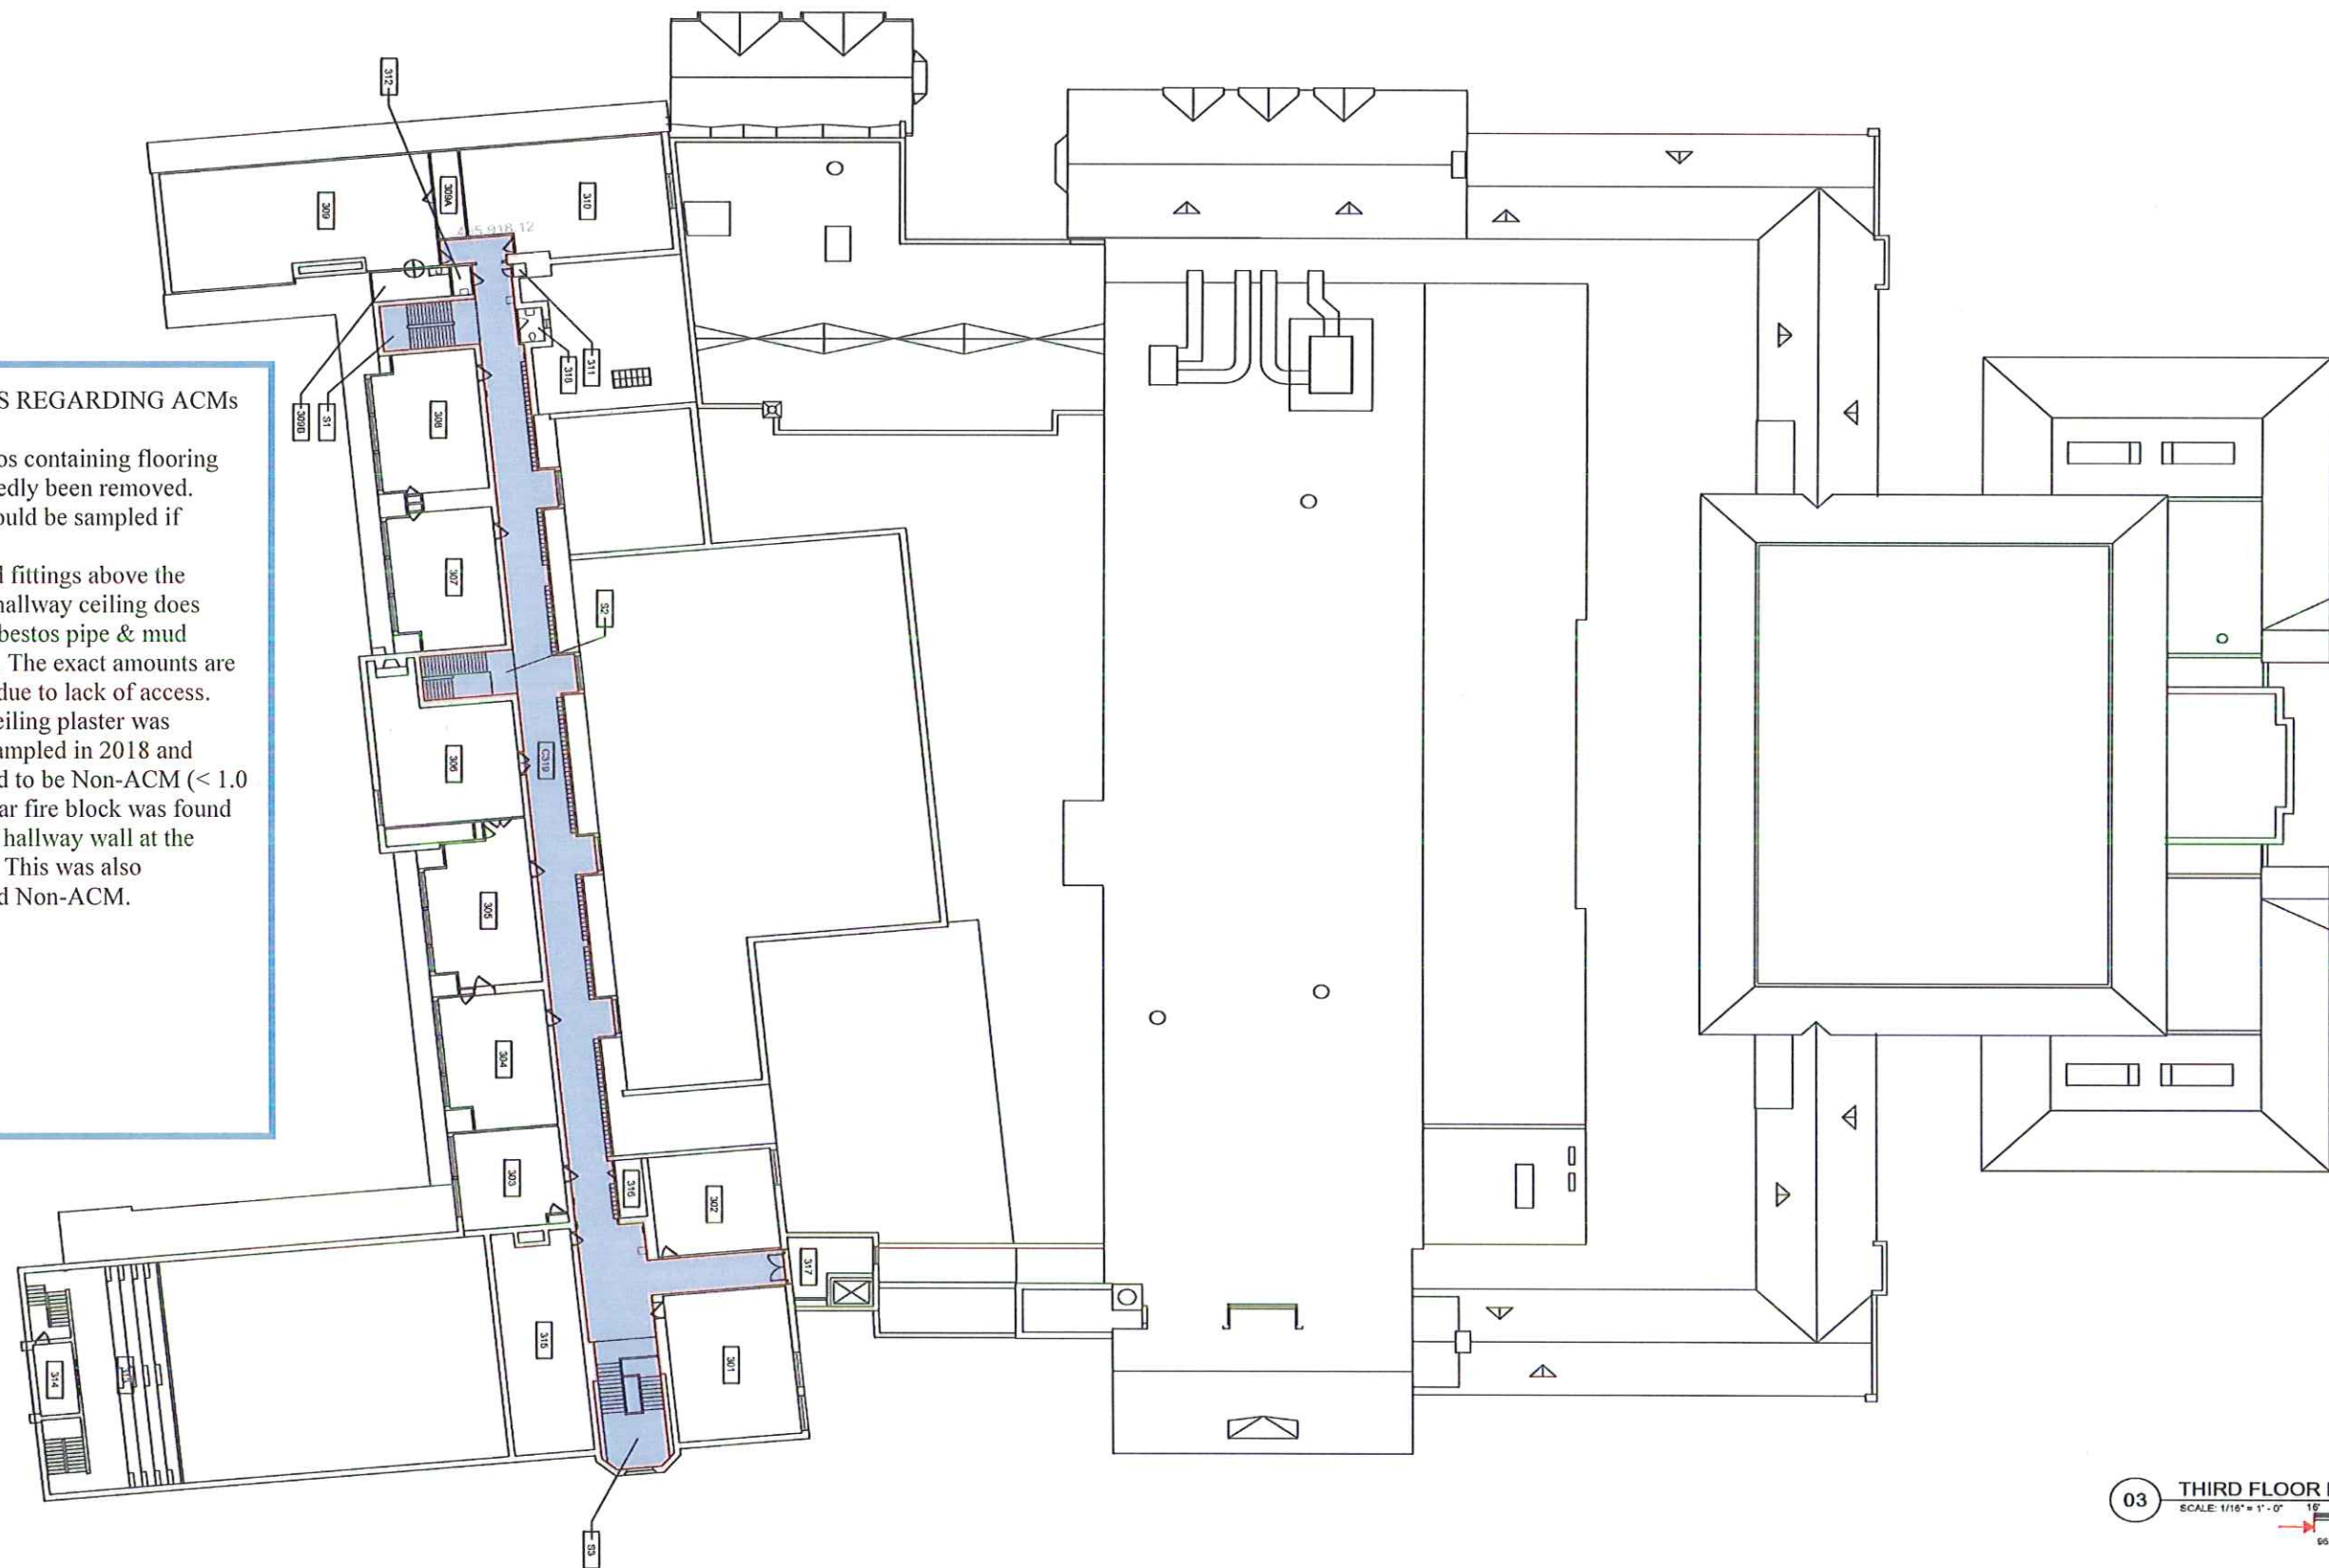
03 THIRD FLOOR PLAN
SCALE: 1/16" = 1' - 0"

1. All asbestos containing flooring has reportedly been removed. Mastic should be sampled if found.
2. Piping and fittings above the plastered hallway ceiling does contain asbestos pipe & mud insulation. The exact amounts are unknown due to lack of access.
3. Wall & Ceiling plaster was recently sampled in 2018 and determined to be Non-ACM (< 1.0 %). Pyrobar fire block was found within the hallway wall at the north end. This was also determined Non-ACM.
