Oakwood Junior High / High School

Oakwood City Schools
Oakwood, Ohio

Technical Building Assessment Report

September 4, 2018

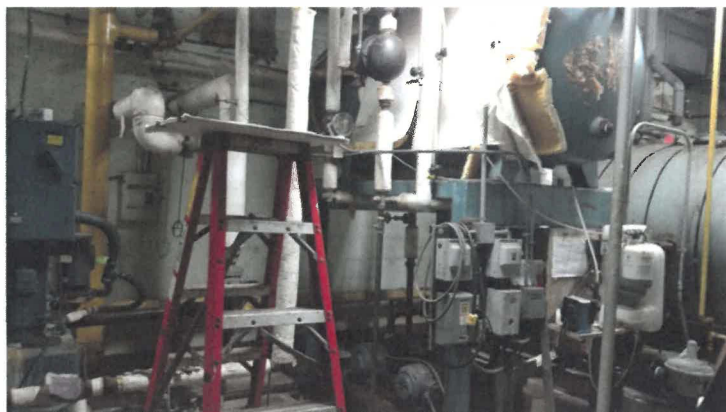
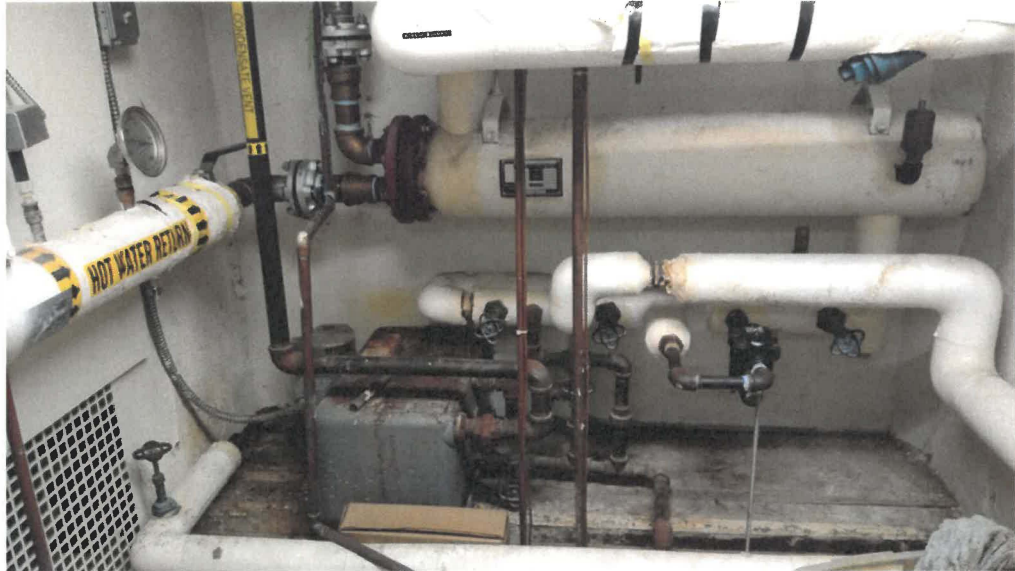
- The 2005 Addition boilers are copper-fin in satisfactory condition and do not require replacement. A change should be considered in the next 5-10 years.
- The existing steam and condensate return piping system is way beyond its useful life and is being recommended for replacement. The copper heating water piping system in the 2005 addition will remain.

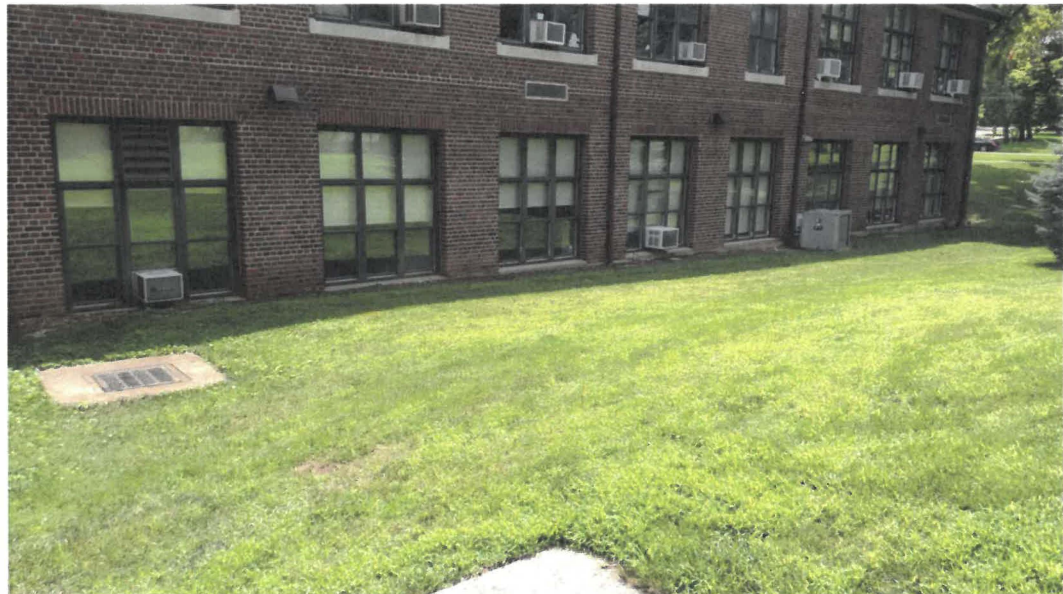
- The existing science wing outdoor air unit was installed in 2000 and is in good condition.
- The locker room heating and exhaust systems were installed in 2005 and are in good condition.
- The existing window air-conditioning units installed throughout the facility are in fair condition, but are not very efficient in operation and have a very short life cycle. The new central chilled water system and air systems should be used to replace the need for these units.

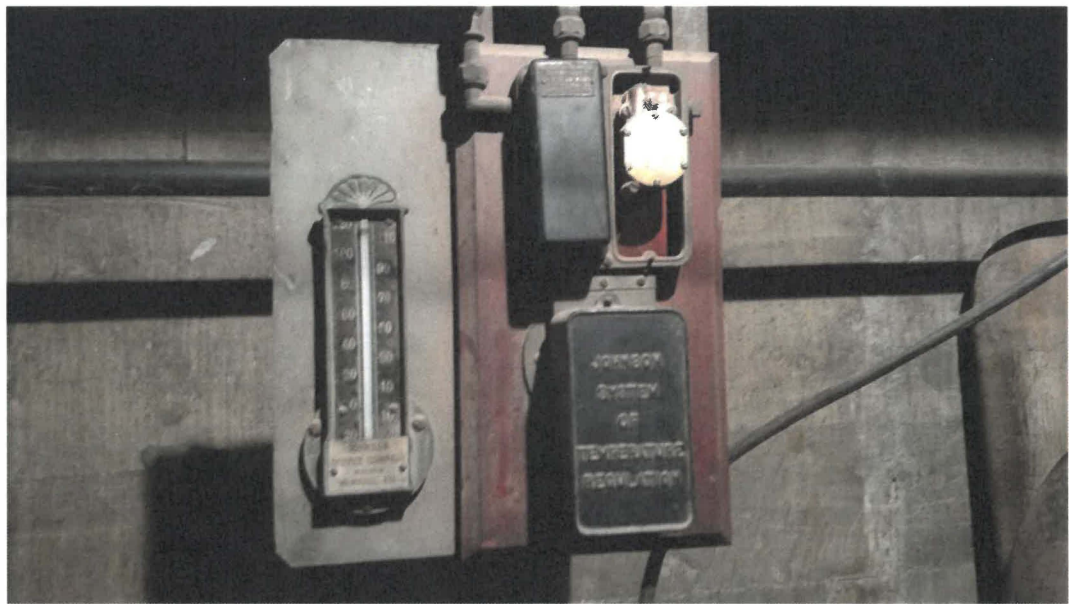
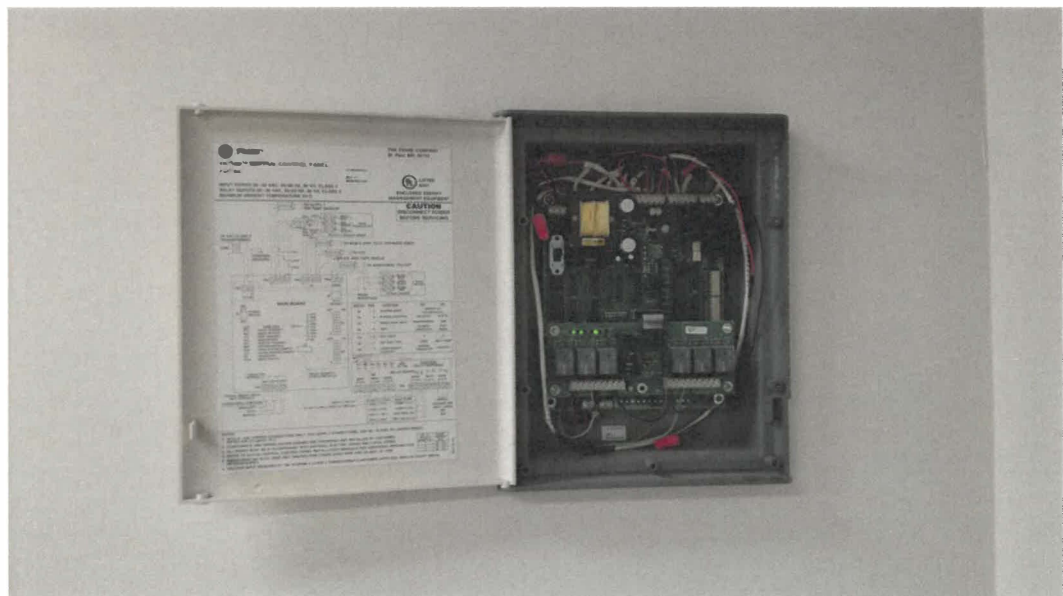
- The VAV rooftop units installed as part of the 2005 addition project are in good condition and should remain.
- In general, the toilet room exhaust systems are operational, although they are fairly aged. We are suggesting a contingency amount of +/- \$40,000 be included in the program to address unknowns.
- The toilet room exhaust systems for the 2005 addition are in good condition and should remain.
- The existing temperature control systems throughout the building with the exception of the 2005 addition are a mixed bag of pneumatic with limited electronic controls. The system should be replaced in its entirety. The 2005 addition did include direct digital control (DDC), but for consistent operation, it should be updated to be compatible with the updated building system.

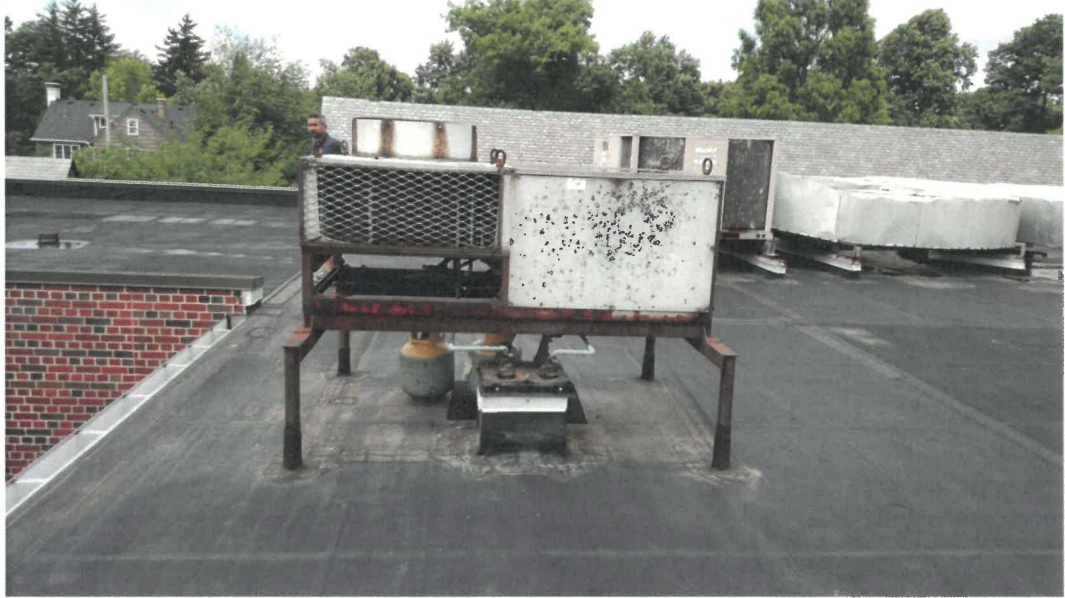
- A new central chilled water system including (2) outdoor, air-cooled water chillers, pumps, piping, specialties, etc. will be needed to serve spaces currently being supported by the outdated DX systems, window air conditioners and spaces not currently being air conditioned.

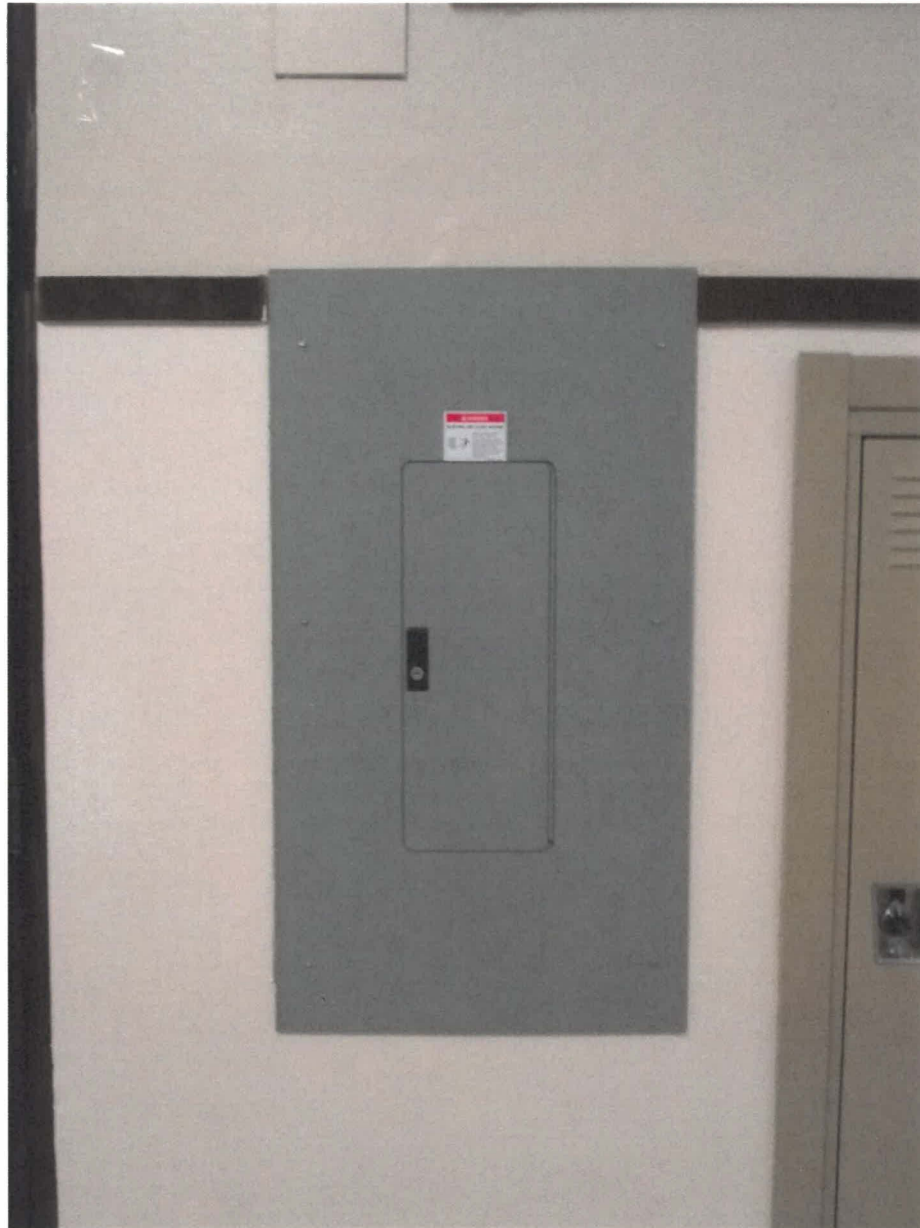
- There are a number of panelboards that have been installed over the past 10-15 years that are in satisfactory condition and should remain in use.

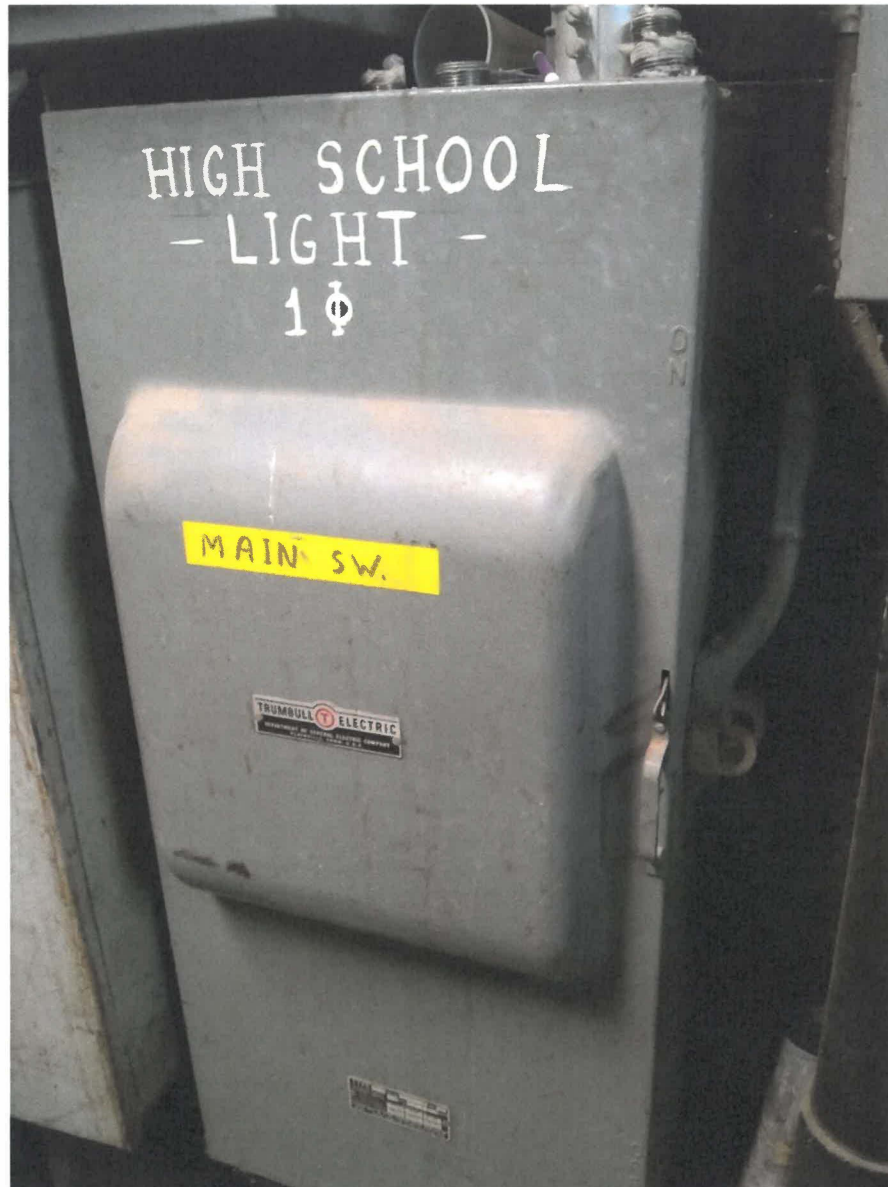
- There are up to 6 old and damaged disconnect switches that are in need of replacement. There are also up to 8 existing disconnect switches that are fairly new and in satisfactory condition that will remain in service.

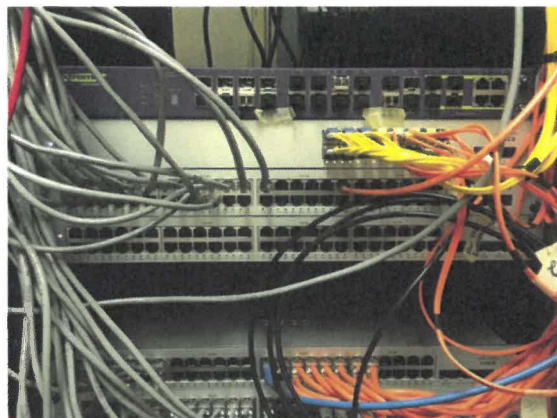
- The existing core switch located in the Main Technology Room has recently been replaced and is not in need of upgrading. The switches in the outlying Technology Closets (edge switching) are in need of upgrading as they are at the end of their useful life. This would also allow an increase in network speed to 10Gb throughout.

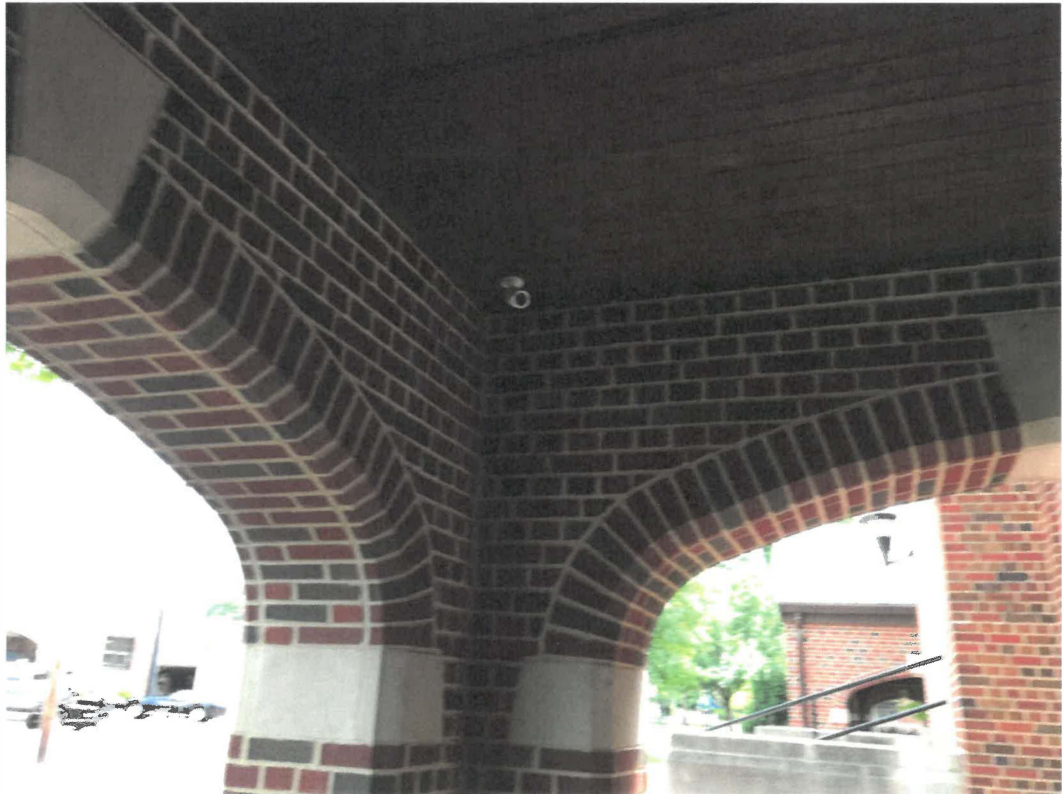
- Currently there is not an Access Control system in the school. An access control system is recommended and should be provided with card readers at 7 doors in the facility.
- Currently there are 30 interior and 7 exterior analog video surveillance cameras. It is recommended to replace the existing analog cameras with higher resolution IP cameras and add an additional 21 interior and 16 exterior IP cameras to provide better video surveillance coverage in the building.
