September 6, 2018

Re: **Smith Elementary, Harman Elementary and Oakwood Junior/Senior High School** - 2/3 Waiver Request

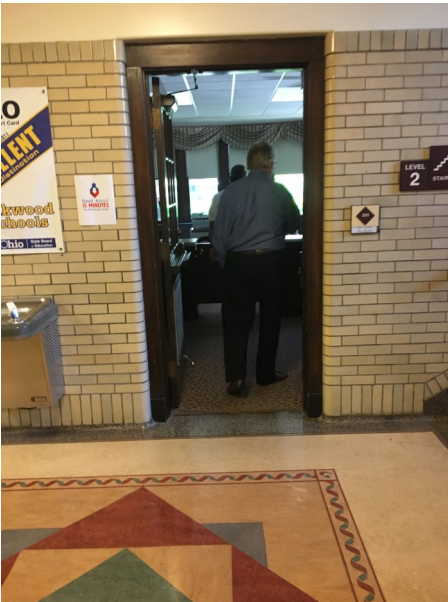
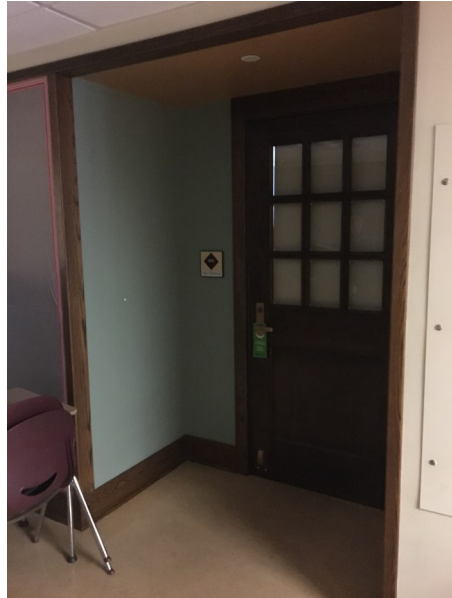
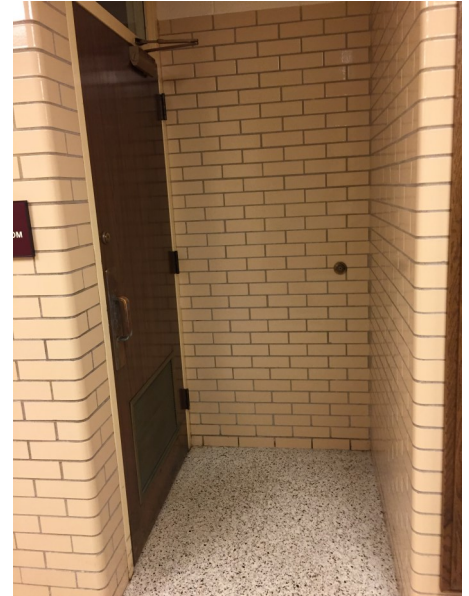
Some door alcoves would need to be adjusted to be ADA accessible. Throughout the building, there are a variety of door alcoves. Building does contain ADA restroom facilities as well as an elevator and an accessible stair by way of chair lift. Corridors are sufficiently wide enough for ADA accessibility.

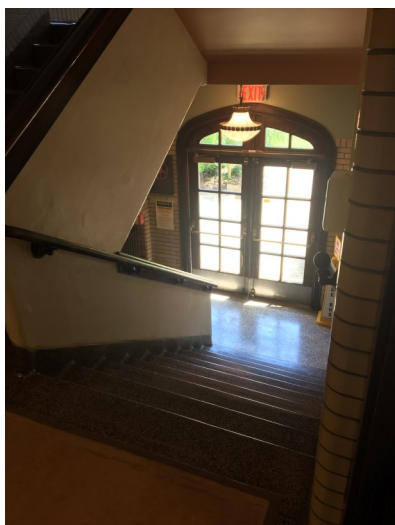
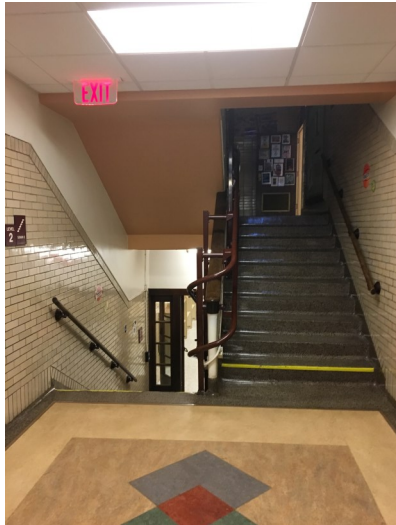
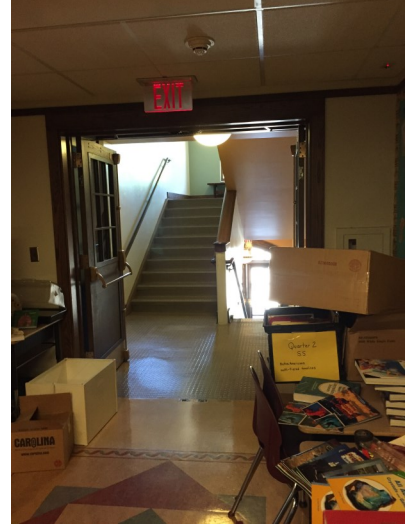
Most stairs throughout the building are open.

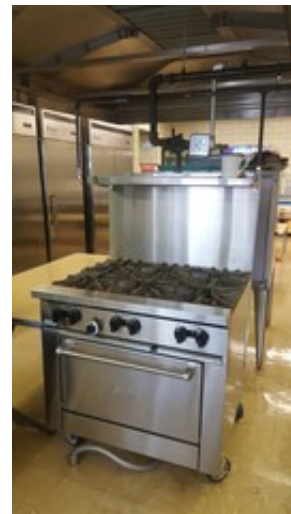
Kitchen Hood and Range
